REVIEW OF ENVIRONMENTAL FACTORS

Addendum #2 – Pre-treatment Plant Lachlan River Pre-Treatment Plant REF

PARKES SHIRE COUNCIL

Review of Environmental Factors – Addendum #2 Lachlan River Pre-treatment Plant

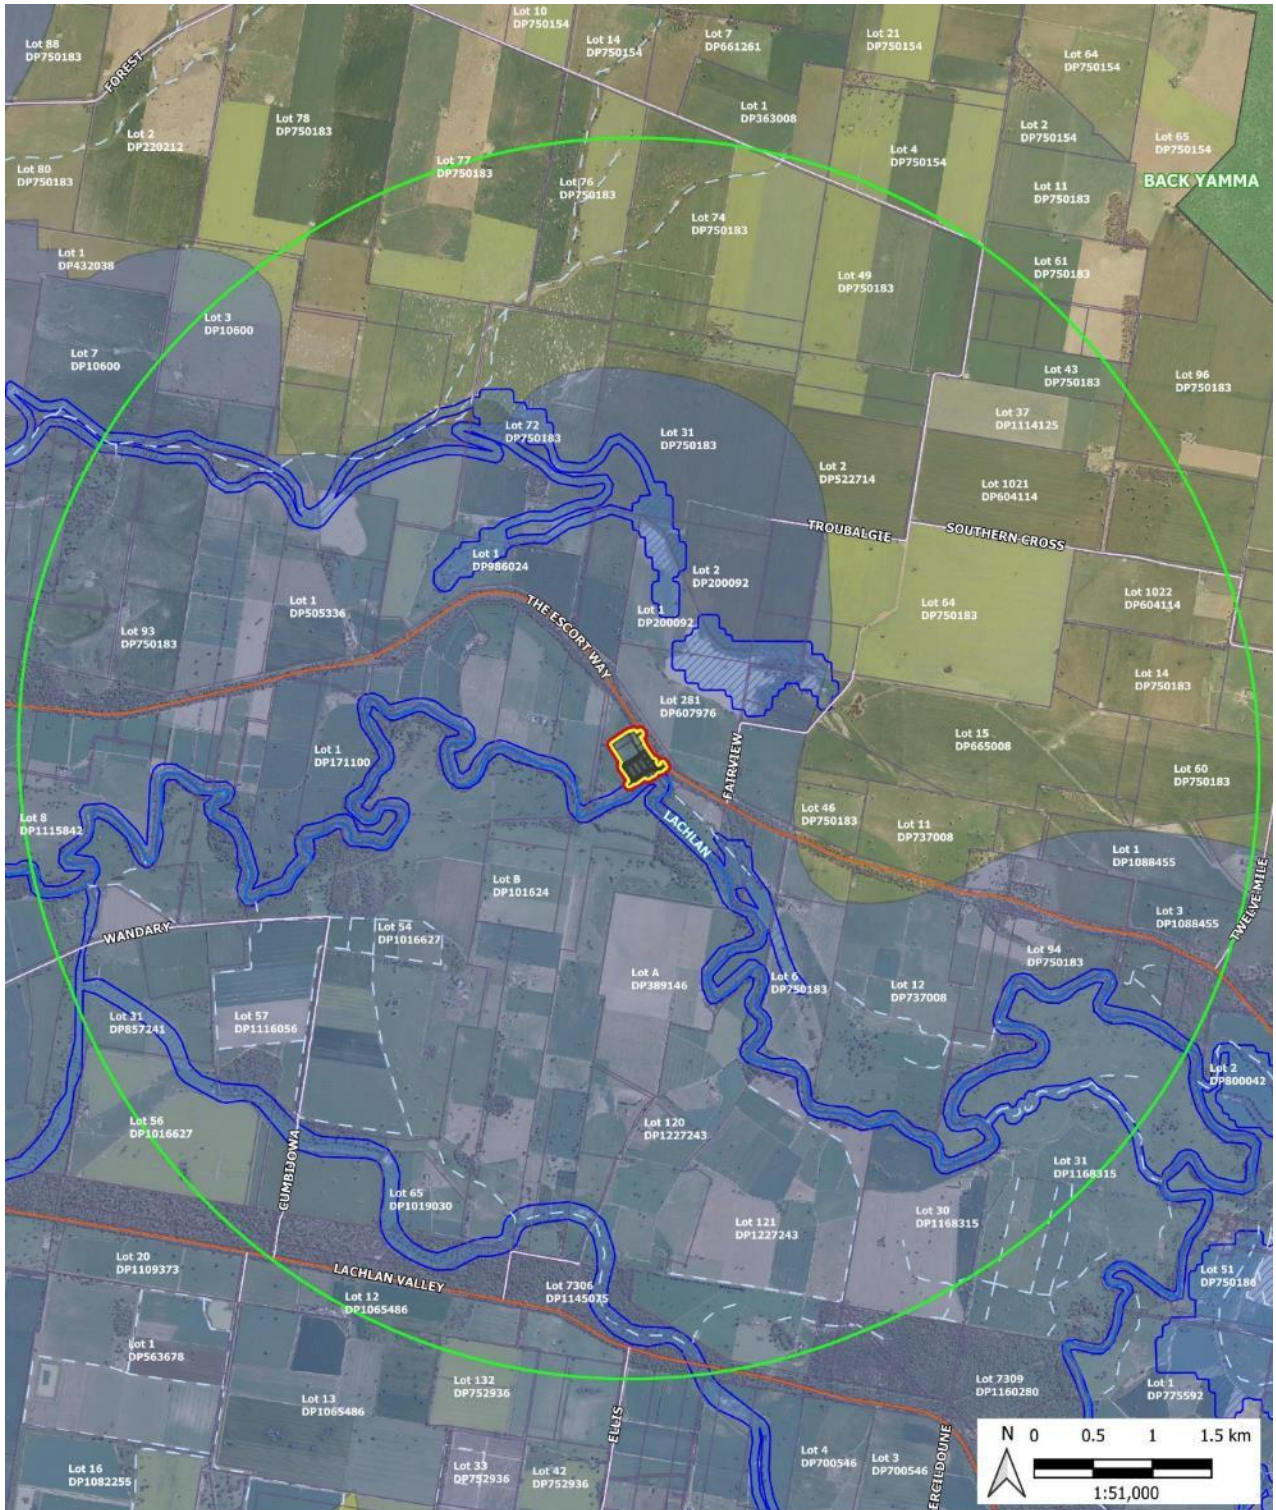
PSC Lachlan River Pre-Treatment Plant REF Addendum - Surface and groundwater within 5km of Proposal

The proposed excavation required to accommodate the PTP works, and ancillary infrastructure works does incur a risk of impact to waterways given the proximity to a major waterway and vulnerable groundwater in the vicinity (refer **Error! Reference source not found.**). The main potential impact to waterways would arise from the potential for spills of fuels and other contaminants during construction which could enter runoff exiting the site and end up in adjacent wetlands and waterways. There is also the risk of sedimentation within surface water exiting the site and impacting on waterways, in particular the Lachlan River. Excavation required for the sediment lagoons and trenching required for any ancillary infrastructure would need to take into consideration the identified groundwater vulnerability of the site (refer Macquarie Geotech *Geotechnical Investigation Report*, 2022, Appendix B), and construction techniques must adhere to the Safeguards outlined in Section 4.2.3.

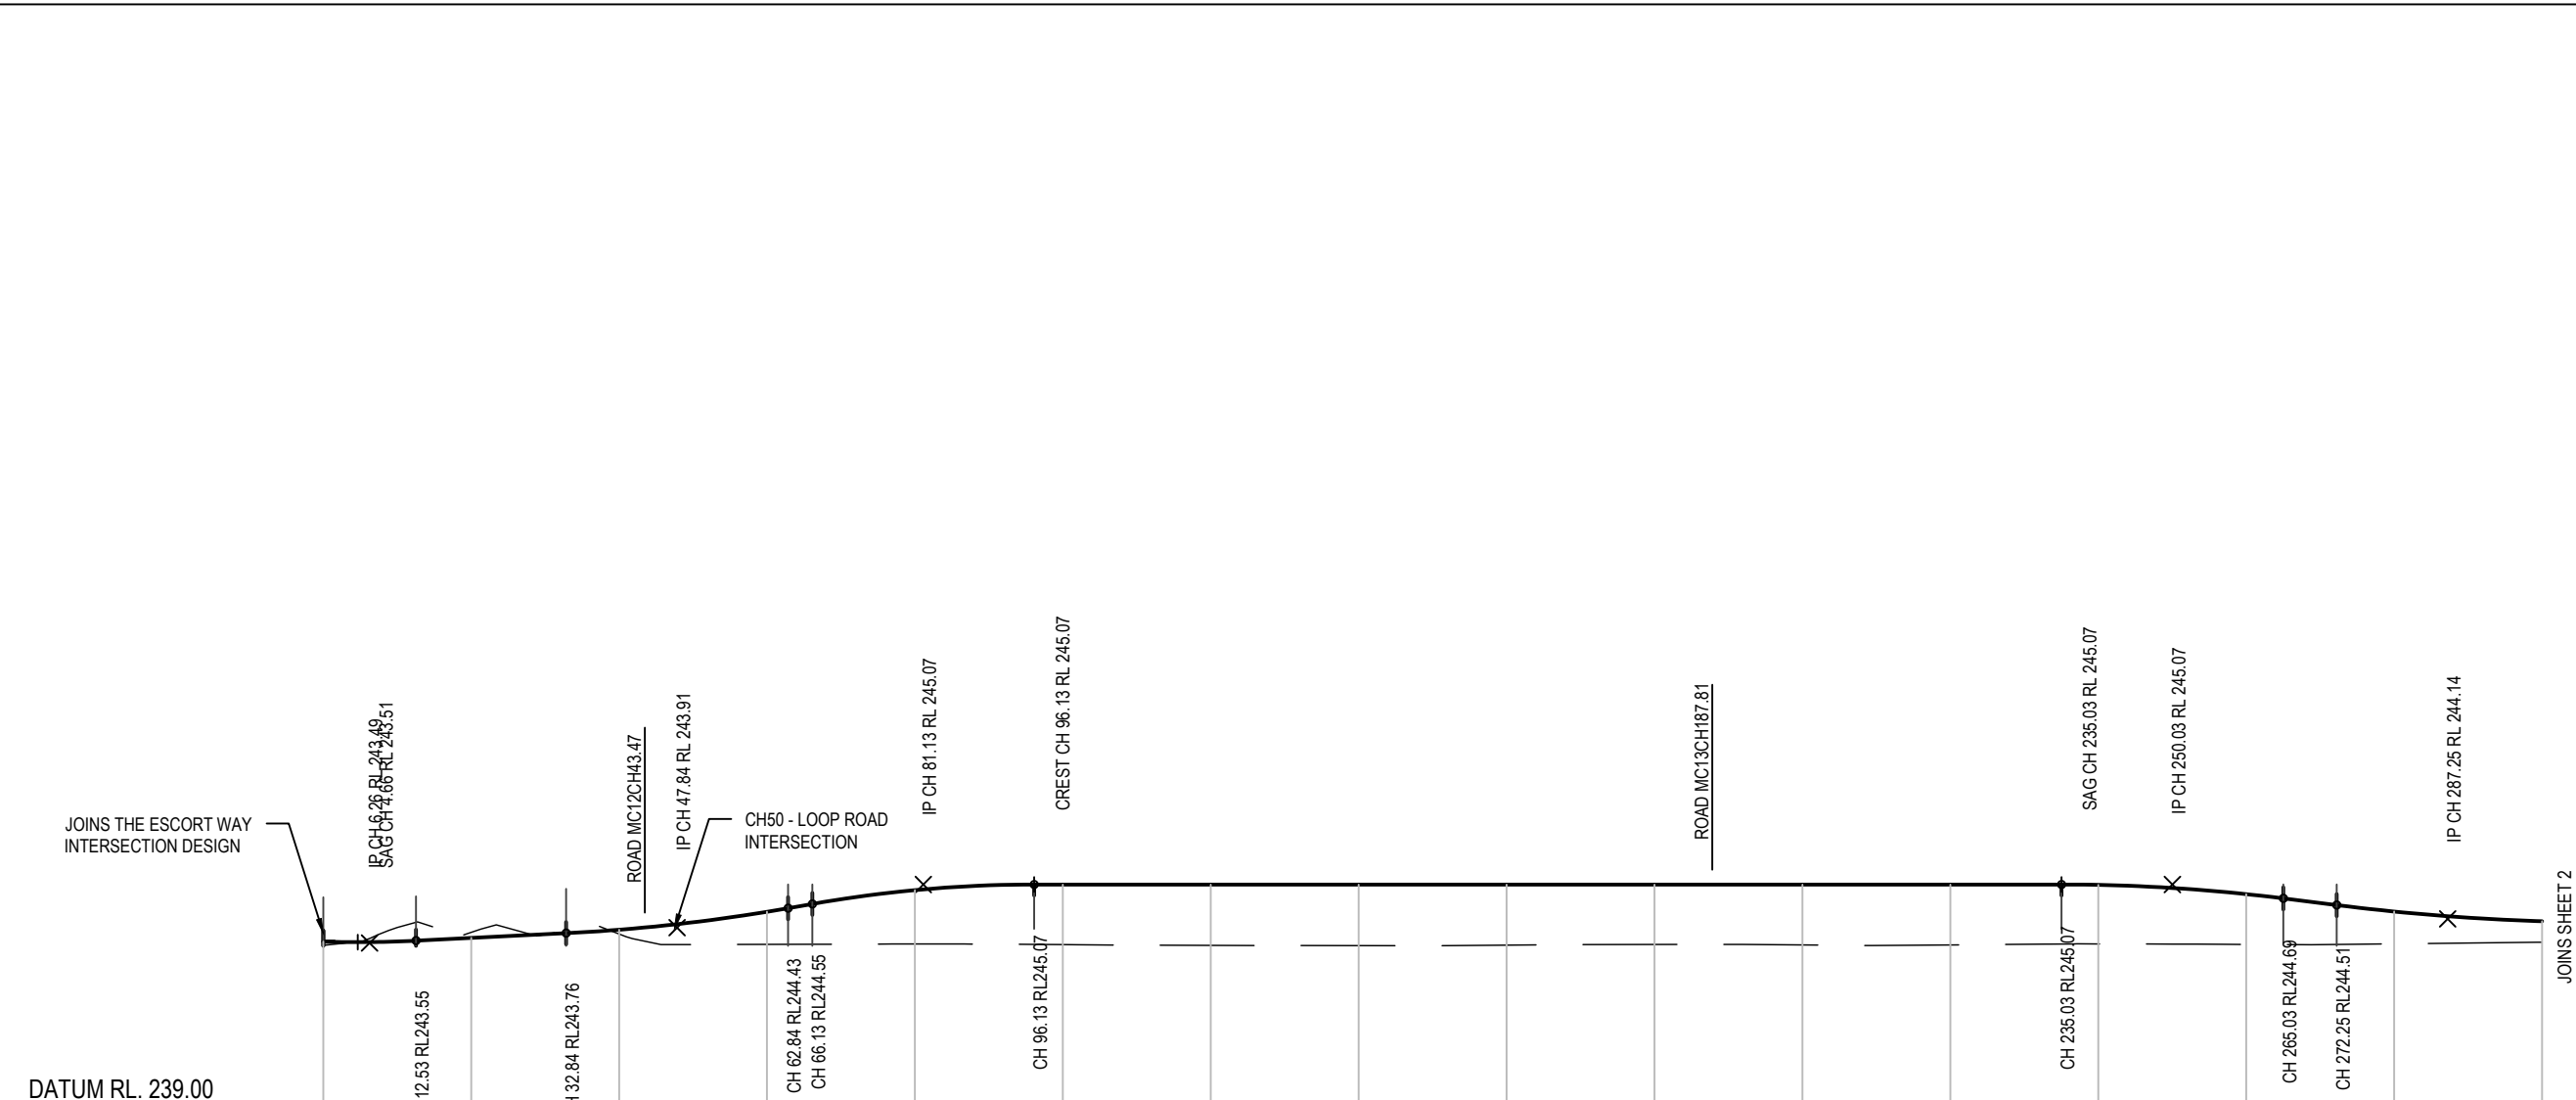
VERTICAL ALIGNMENT	K=7.86 L=12.53m G=-0.59%	L=20.32m G=1%	K=12 L=30m	L=3.28m G=3.9%	K=8.57 L=30m	L=138.9m G=0%	K=12 L=30m	L=7.22m G=-2.5%	K=15 L=30m								
HORIZONTAL ALIGNMENT	L=2.04m R=32.19m	L=15.00m R=32.19m	L=59.88m	L=25.00m R=21.97m	L=130.92m	L=32.99m R=21.00m	L=137.30m										
LEVEL DIFFERENCE CUT - / FILL +	0.10	-0.15	0.12	0.88	1.46	1.62	1.64	1.65	1.64	1.62	1.63	1.63	1.59	1.36	0.87	0.57	
DESIGN SURFACE LEVEL	243.526	243.627	243.848	244.334	244.918	245.070	245.070	245.070	245.070	245.070	245.070	245.070	245.070	245.060	244.810	244.341	244.077
EXISTING SURFACE LEVEL	243.43	243.78	243.73	243.45	243.46	243.45	243.43	243.42	243.43	243.45	243.44	243.44	243.44	243.47	243.45	243.47	243.51
CHAINAGE	0.000	20.000	40.000	60.000	80.000	100.000	120.000	140.000	160.000	180.000	200.000	220.000	240.000	260.000	280.000	300.000

LONGITUDINAL SECTION - ROAD MC11
 HORIZONTAL SCALE 1:1000
 VERTICAL SCALE 1:200

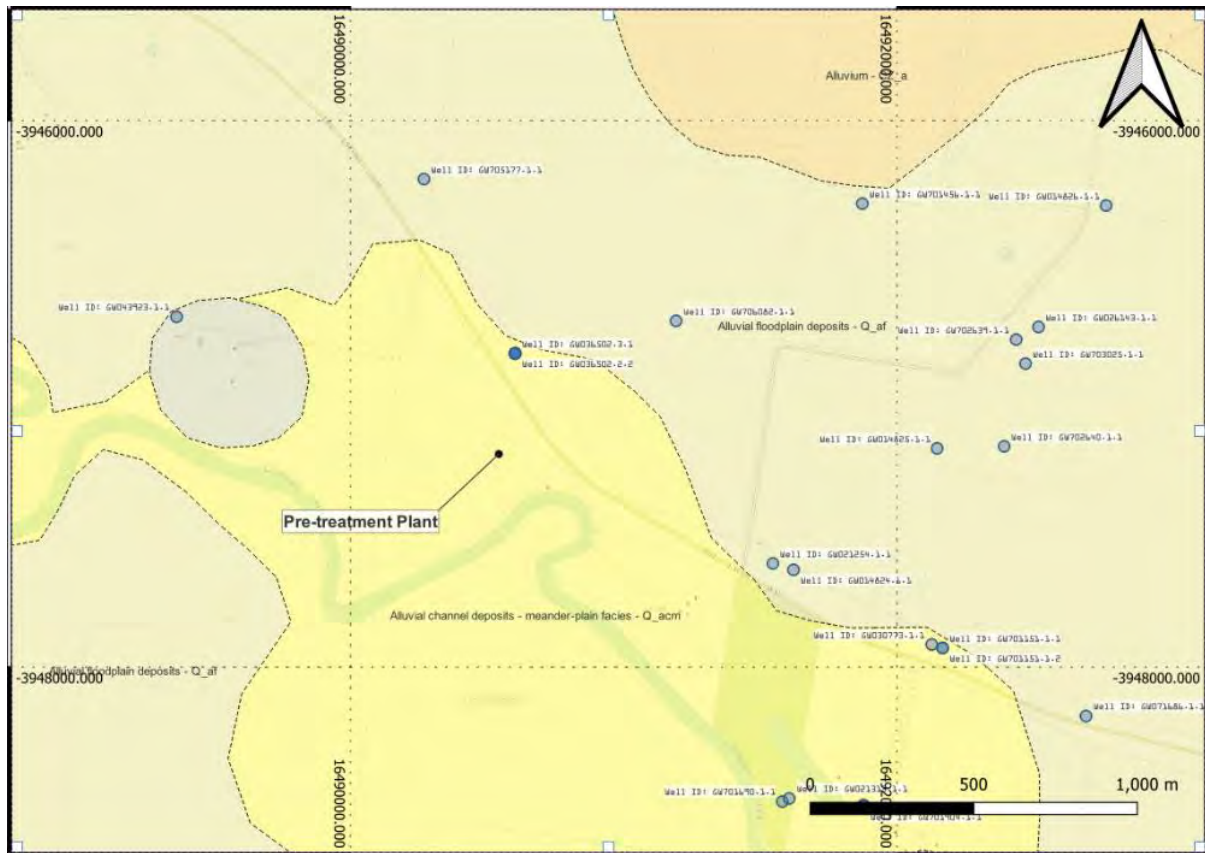
Figure 2: Seamless Geological Map Overlay

The NSW seamless geological map is shown in Figure 2 below, with NSW Groundwater Bore locations overlaid.

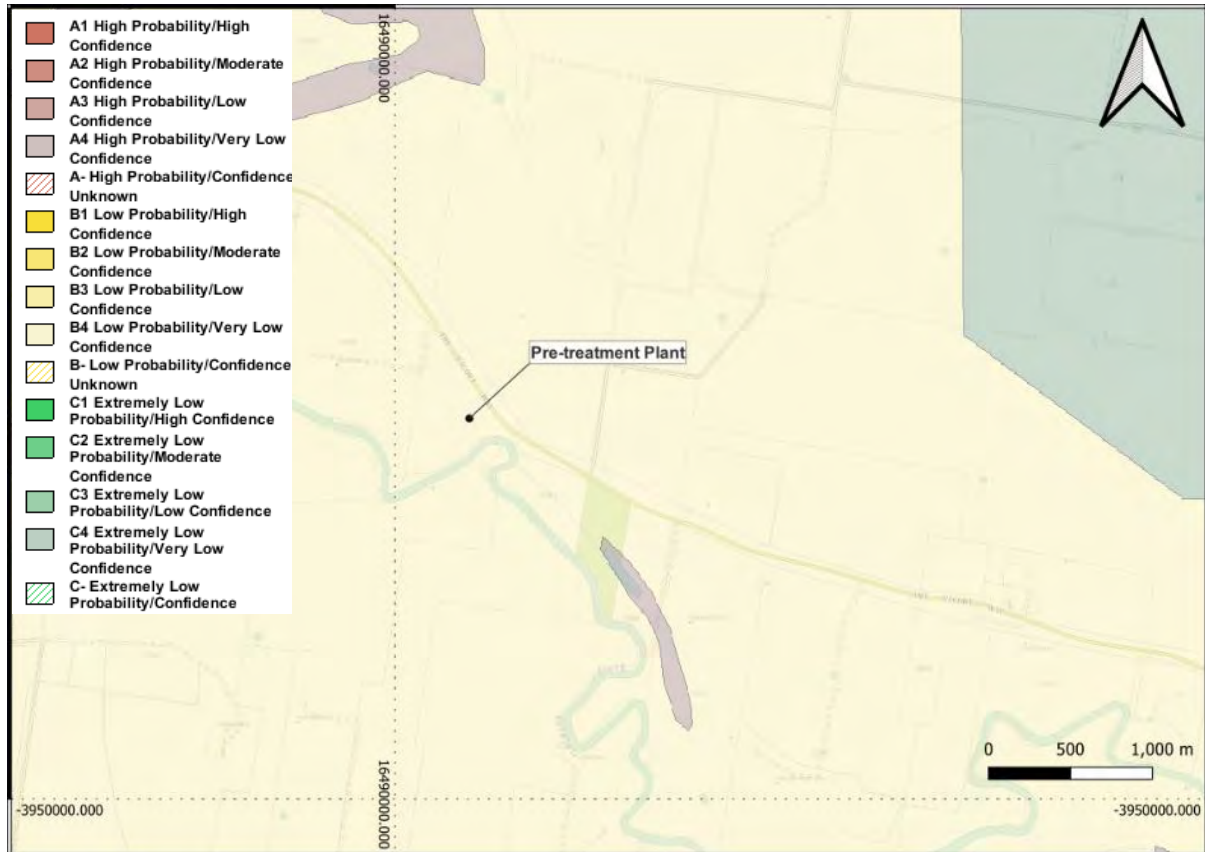
Figure 3: Acid Sulphate Risk Map

The acid sulphate risk map indicates a low probability of acid sulphate soils at the site.

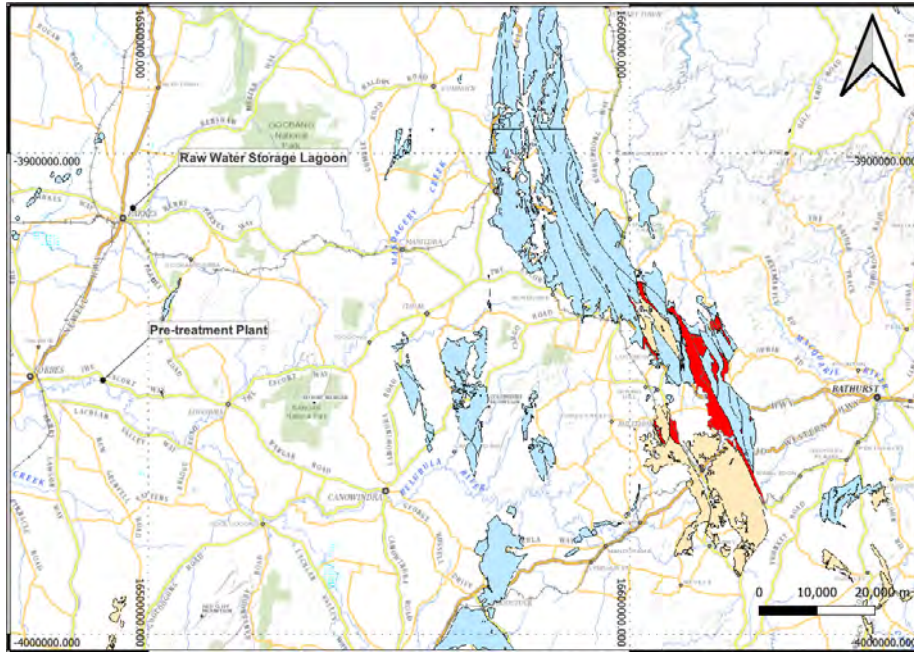
Figure 4: Naturally Occurring Asbestos Hazard Map

The Hazard Map indicates no known Naturally Occurring Asbestos (NOA) at the site.

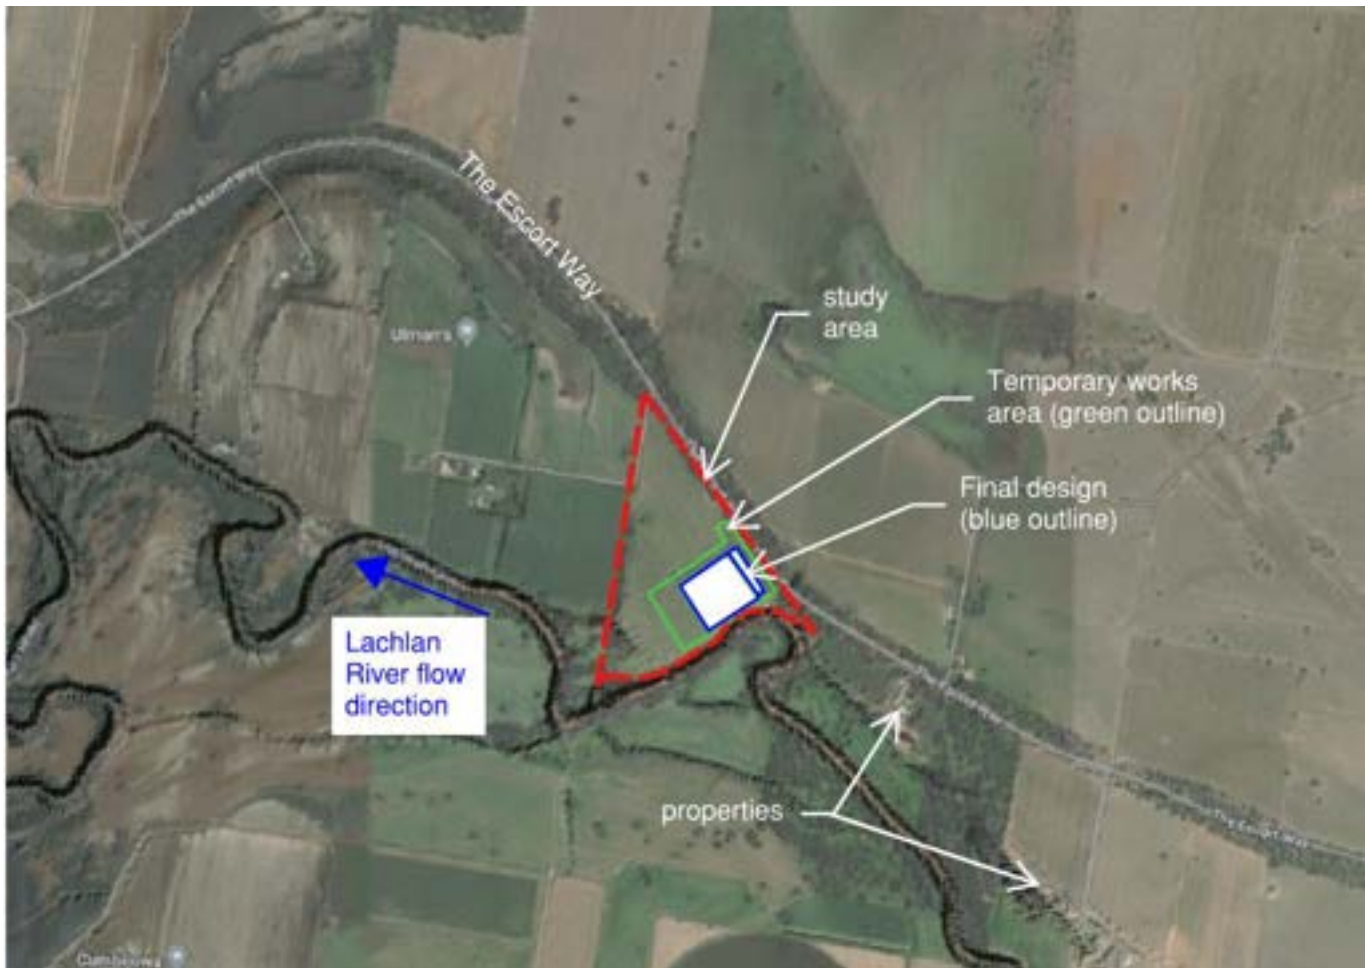
Figure 2 Tuflow model layout

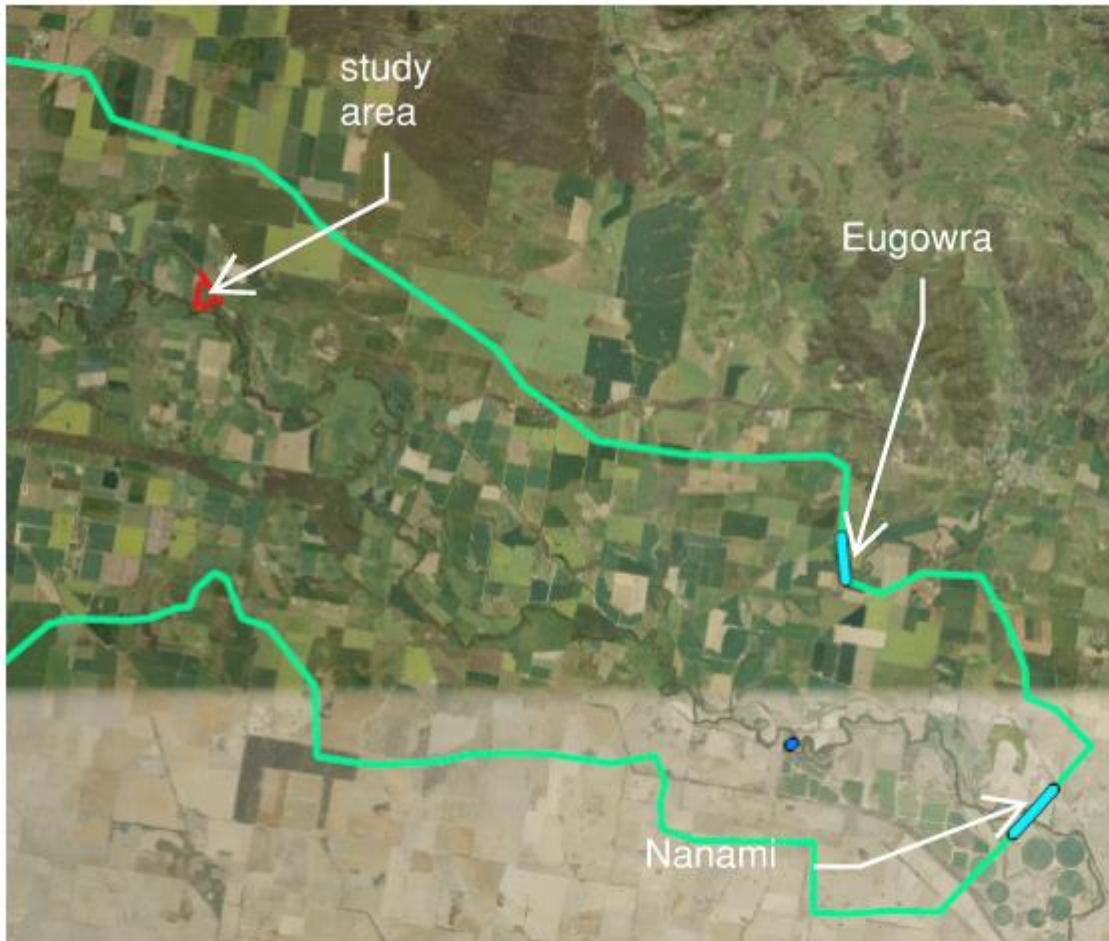
The design flows derived from Forbes Flood Study (2020) and have been applied at two inflow locations as seen in Figure 3 (Eugowra and Nanami). Each of the inflow peak flow values summarised in Table 3. Forbes flood study was completed recently in 2020 and it is believed that hydrology is suitable for this project. Local catchment flooding was not considered for this site as Lachlan River is dominating flood levels for the site.

Figure 3 Tuflow model inflow locations.

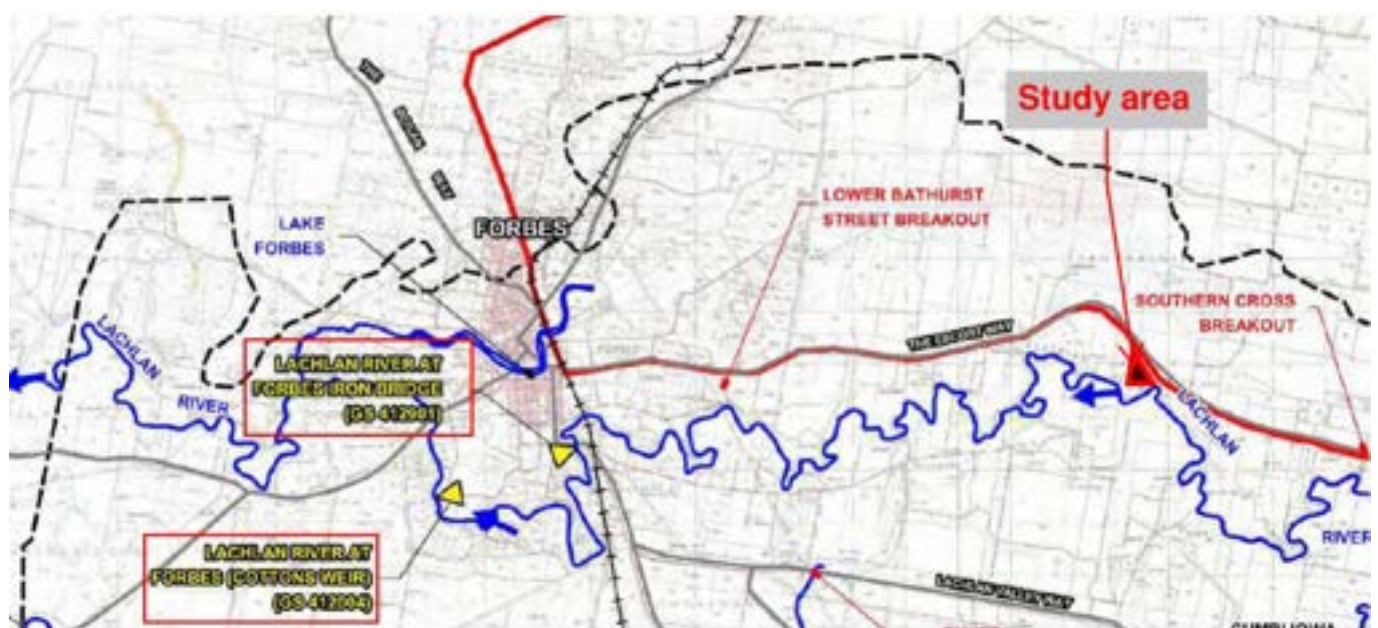
Figure 4: Stream Gauge Locations used for Validation.

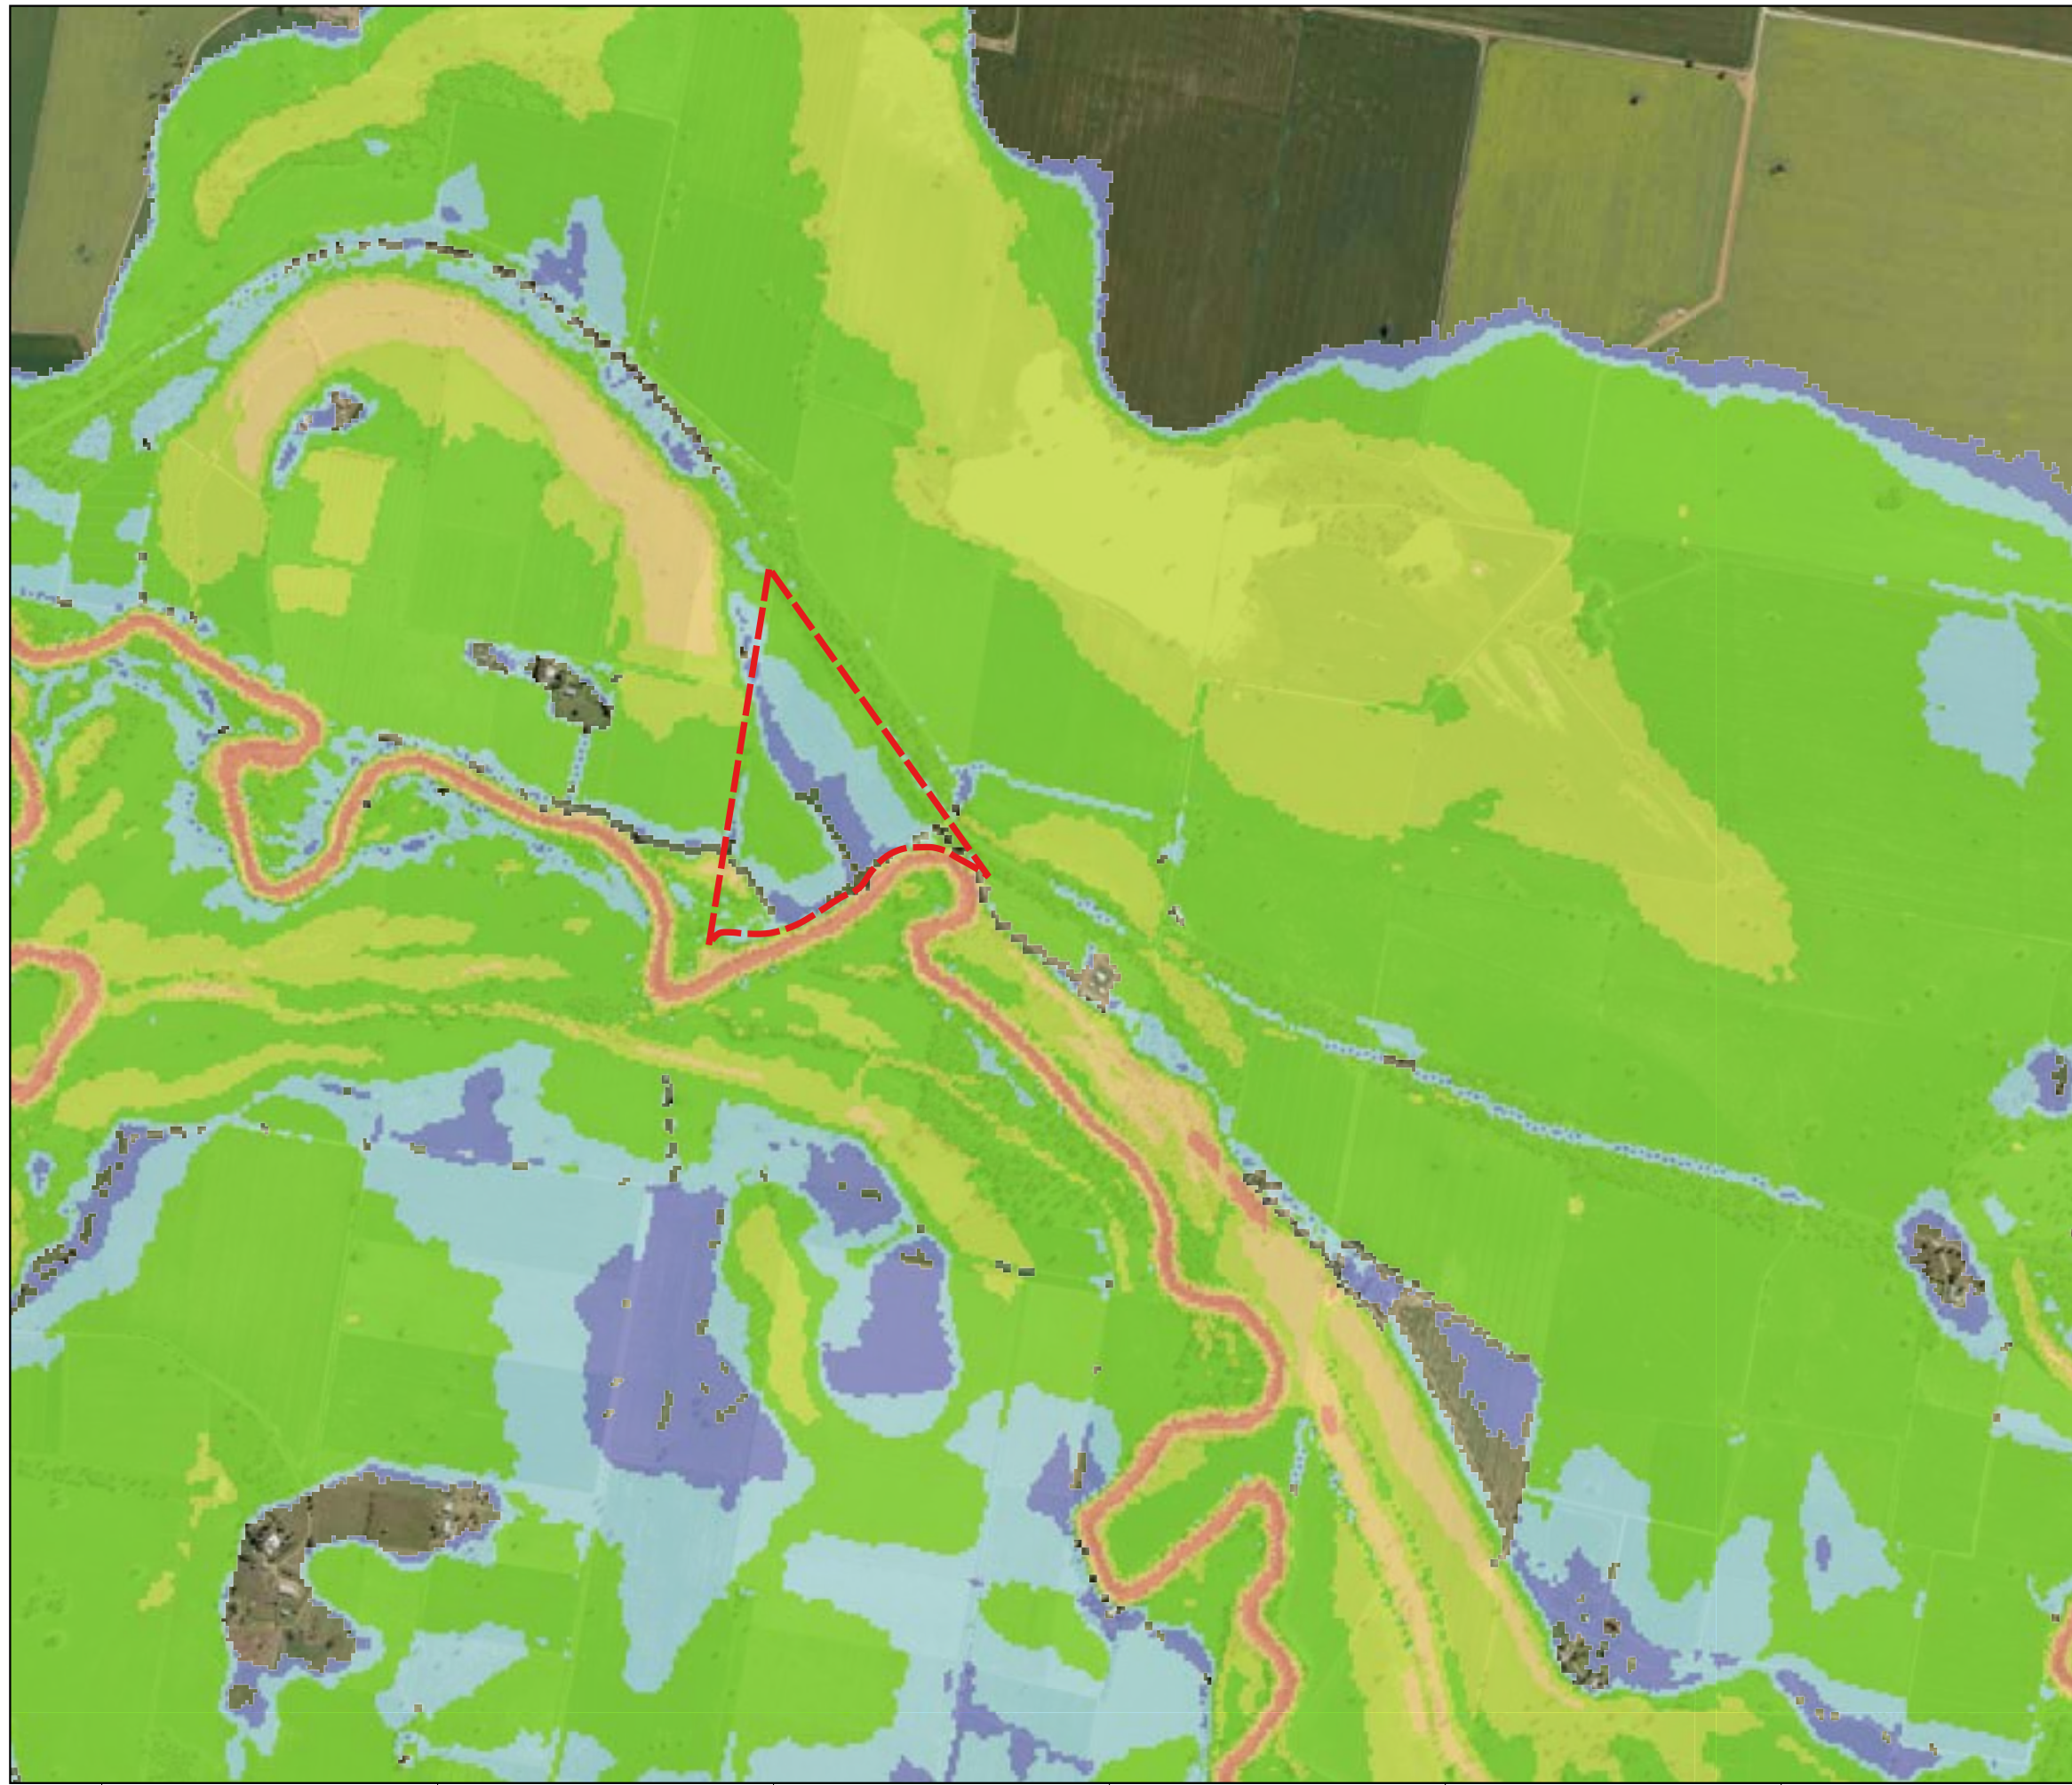
SE22026 Lachlan River Pre-Treatment Lagoons
 Figure 6
 Existing Scenario - Flood Hazard 5% AEP

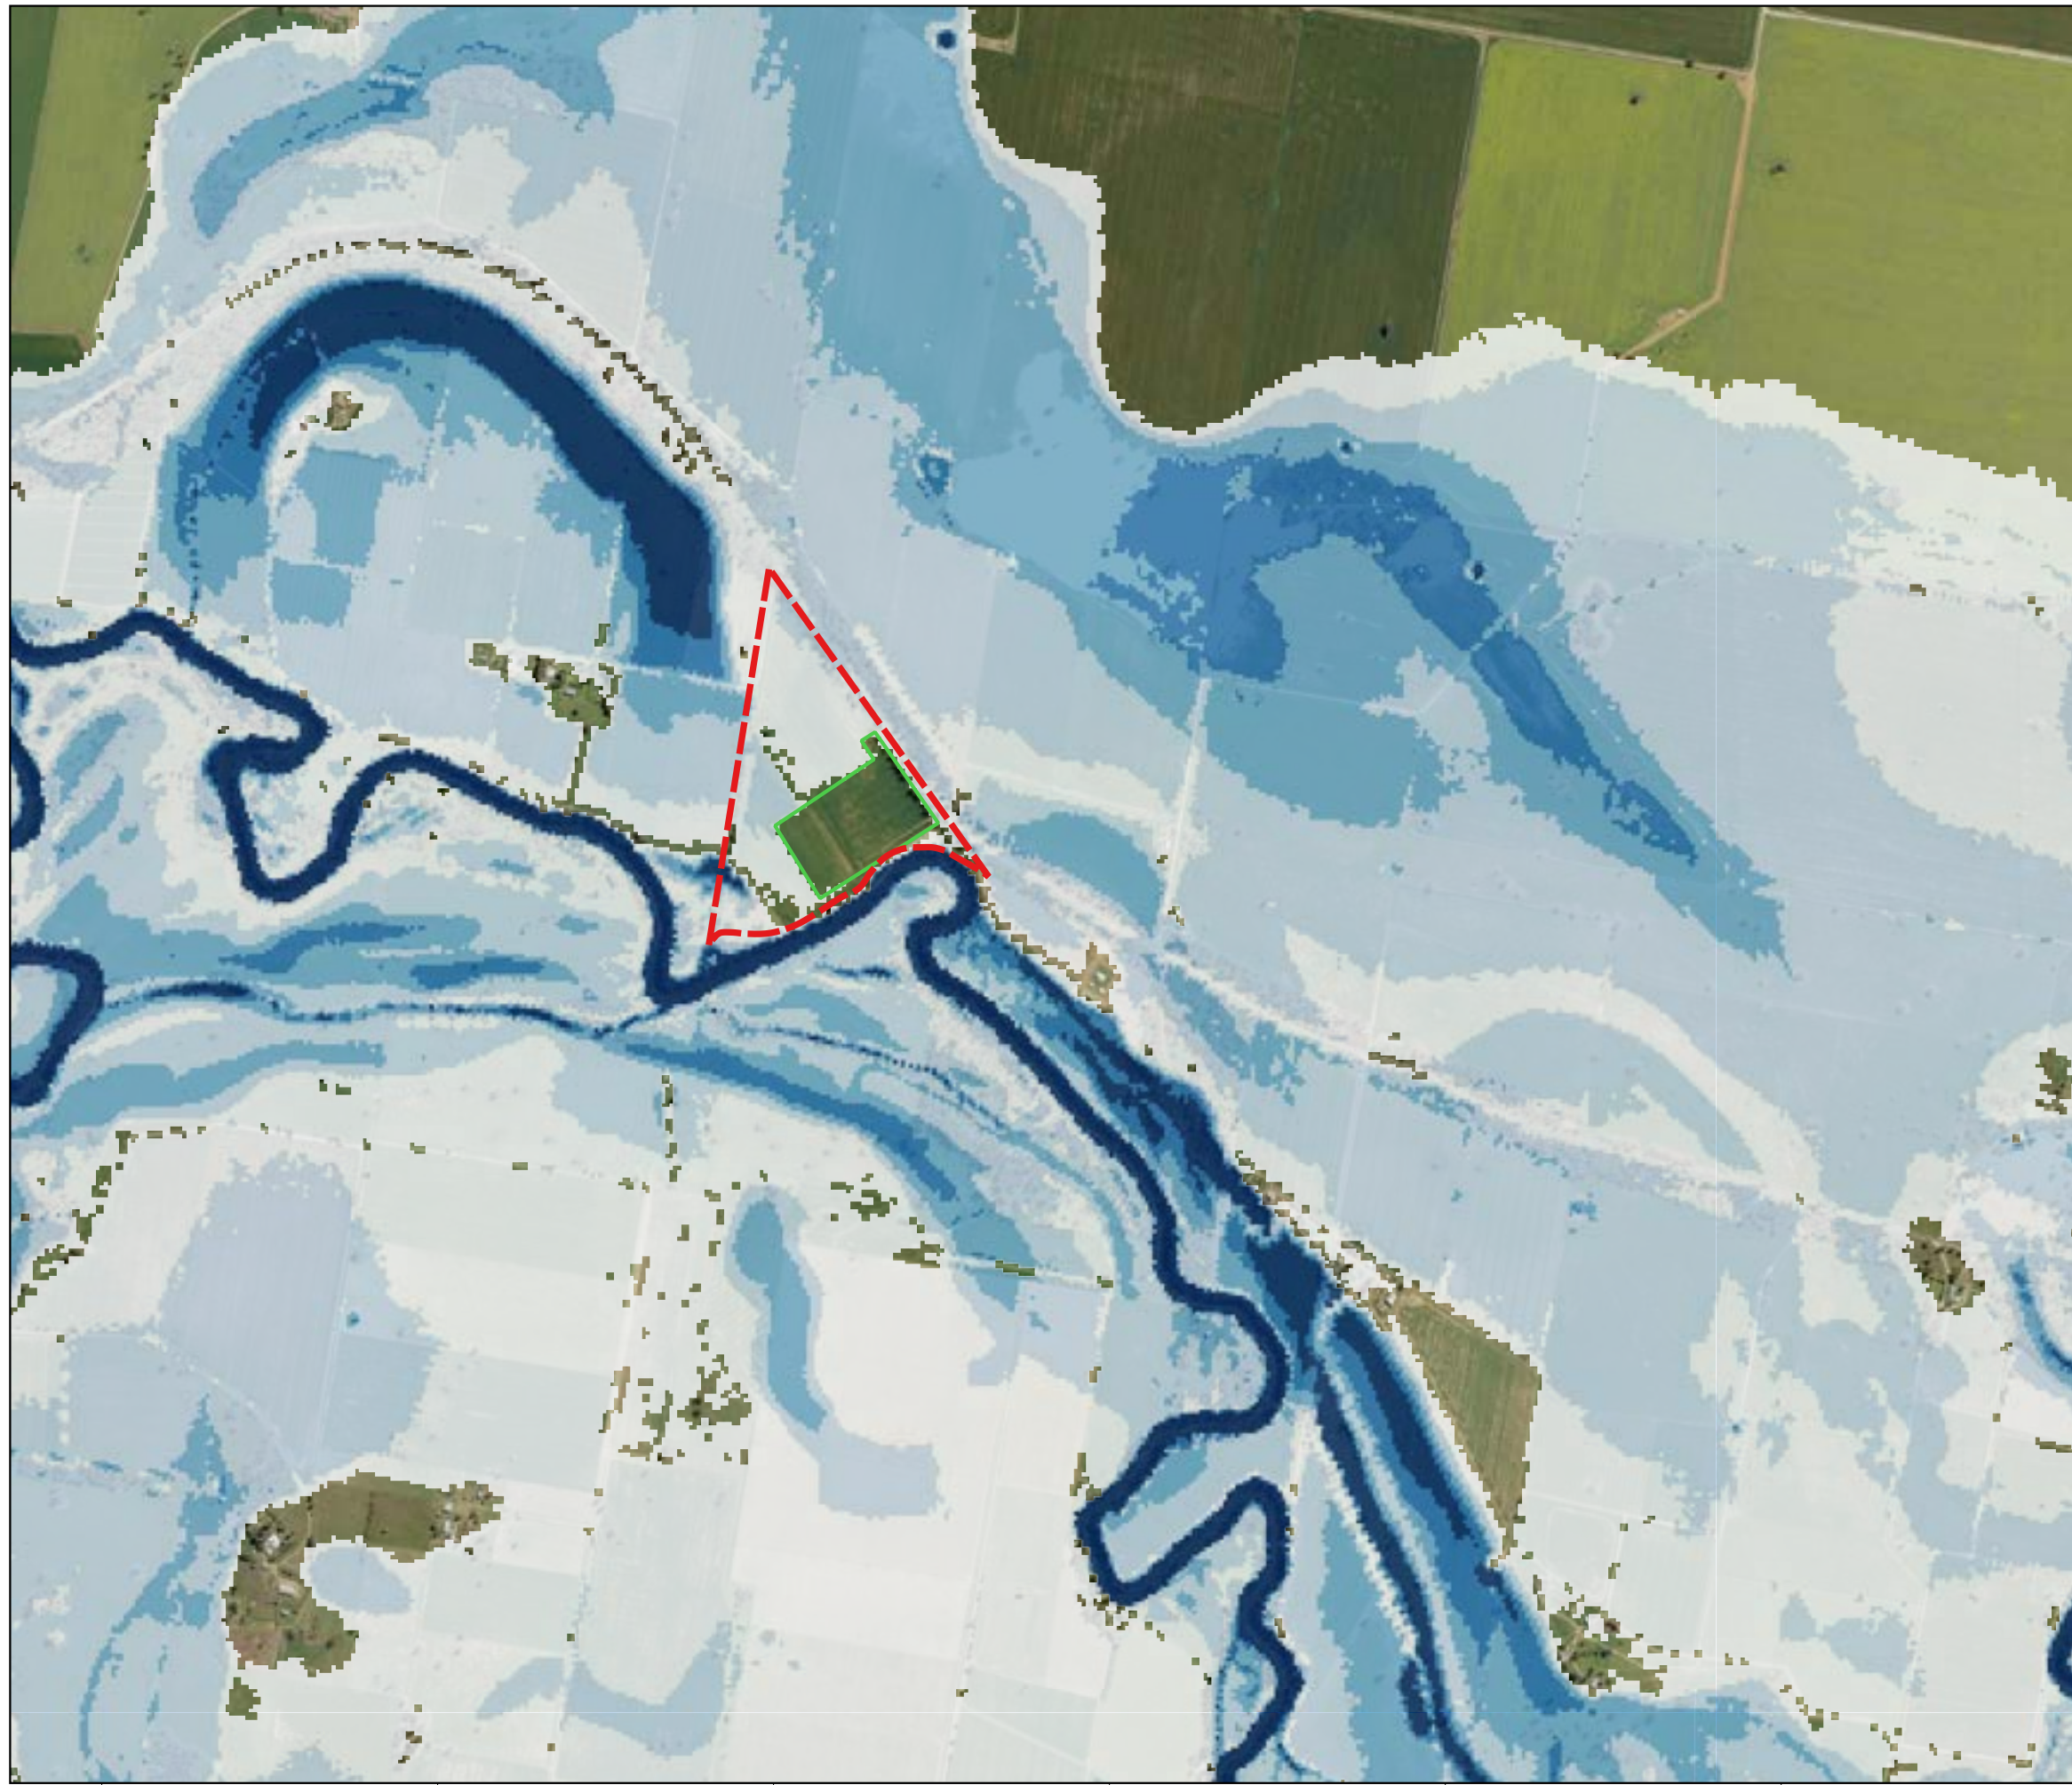
SE22026 Lachlan River Pre-Treatment Lagoons
 Figure 8
 Interim Scenario - Flood Depth 10% AEP

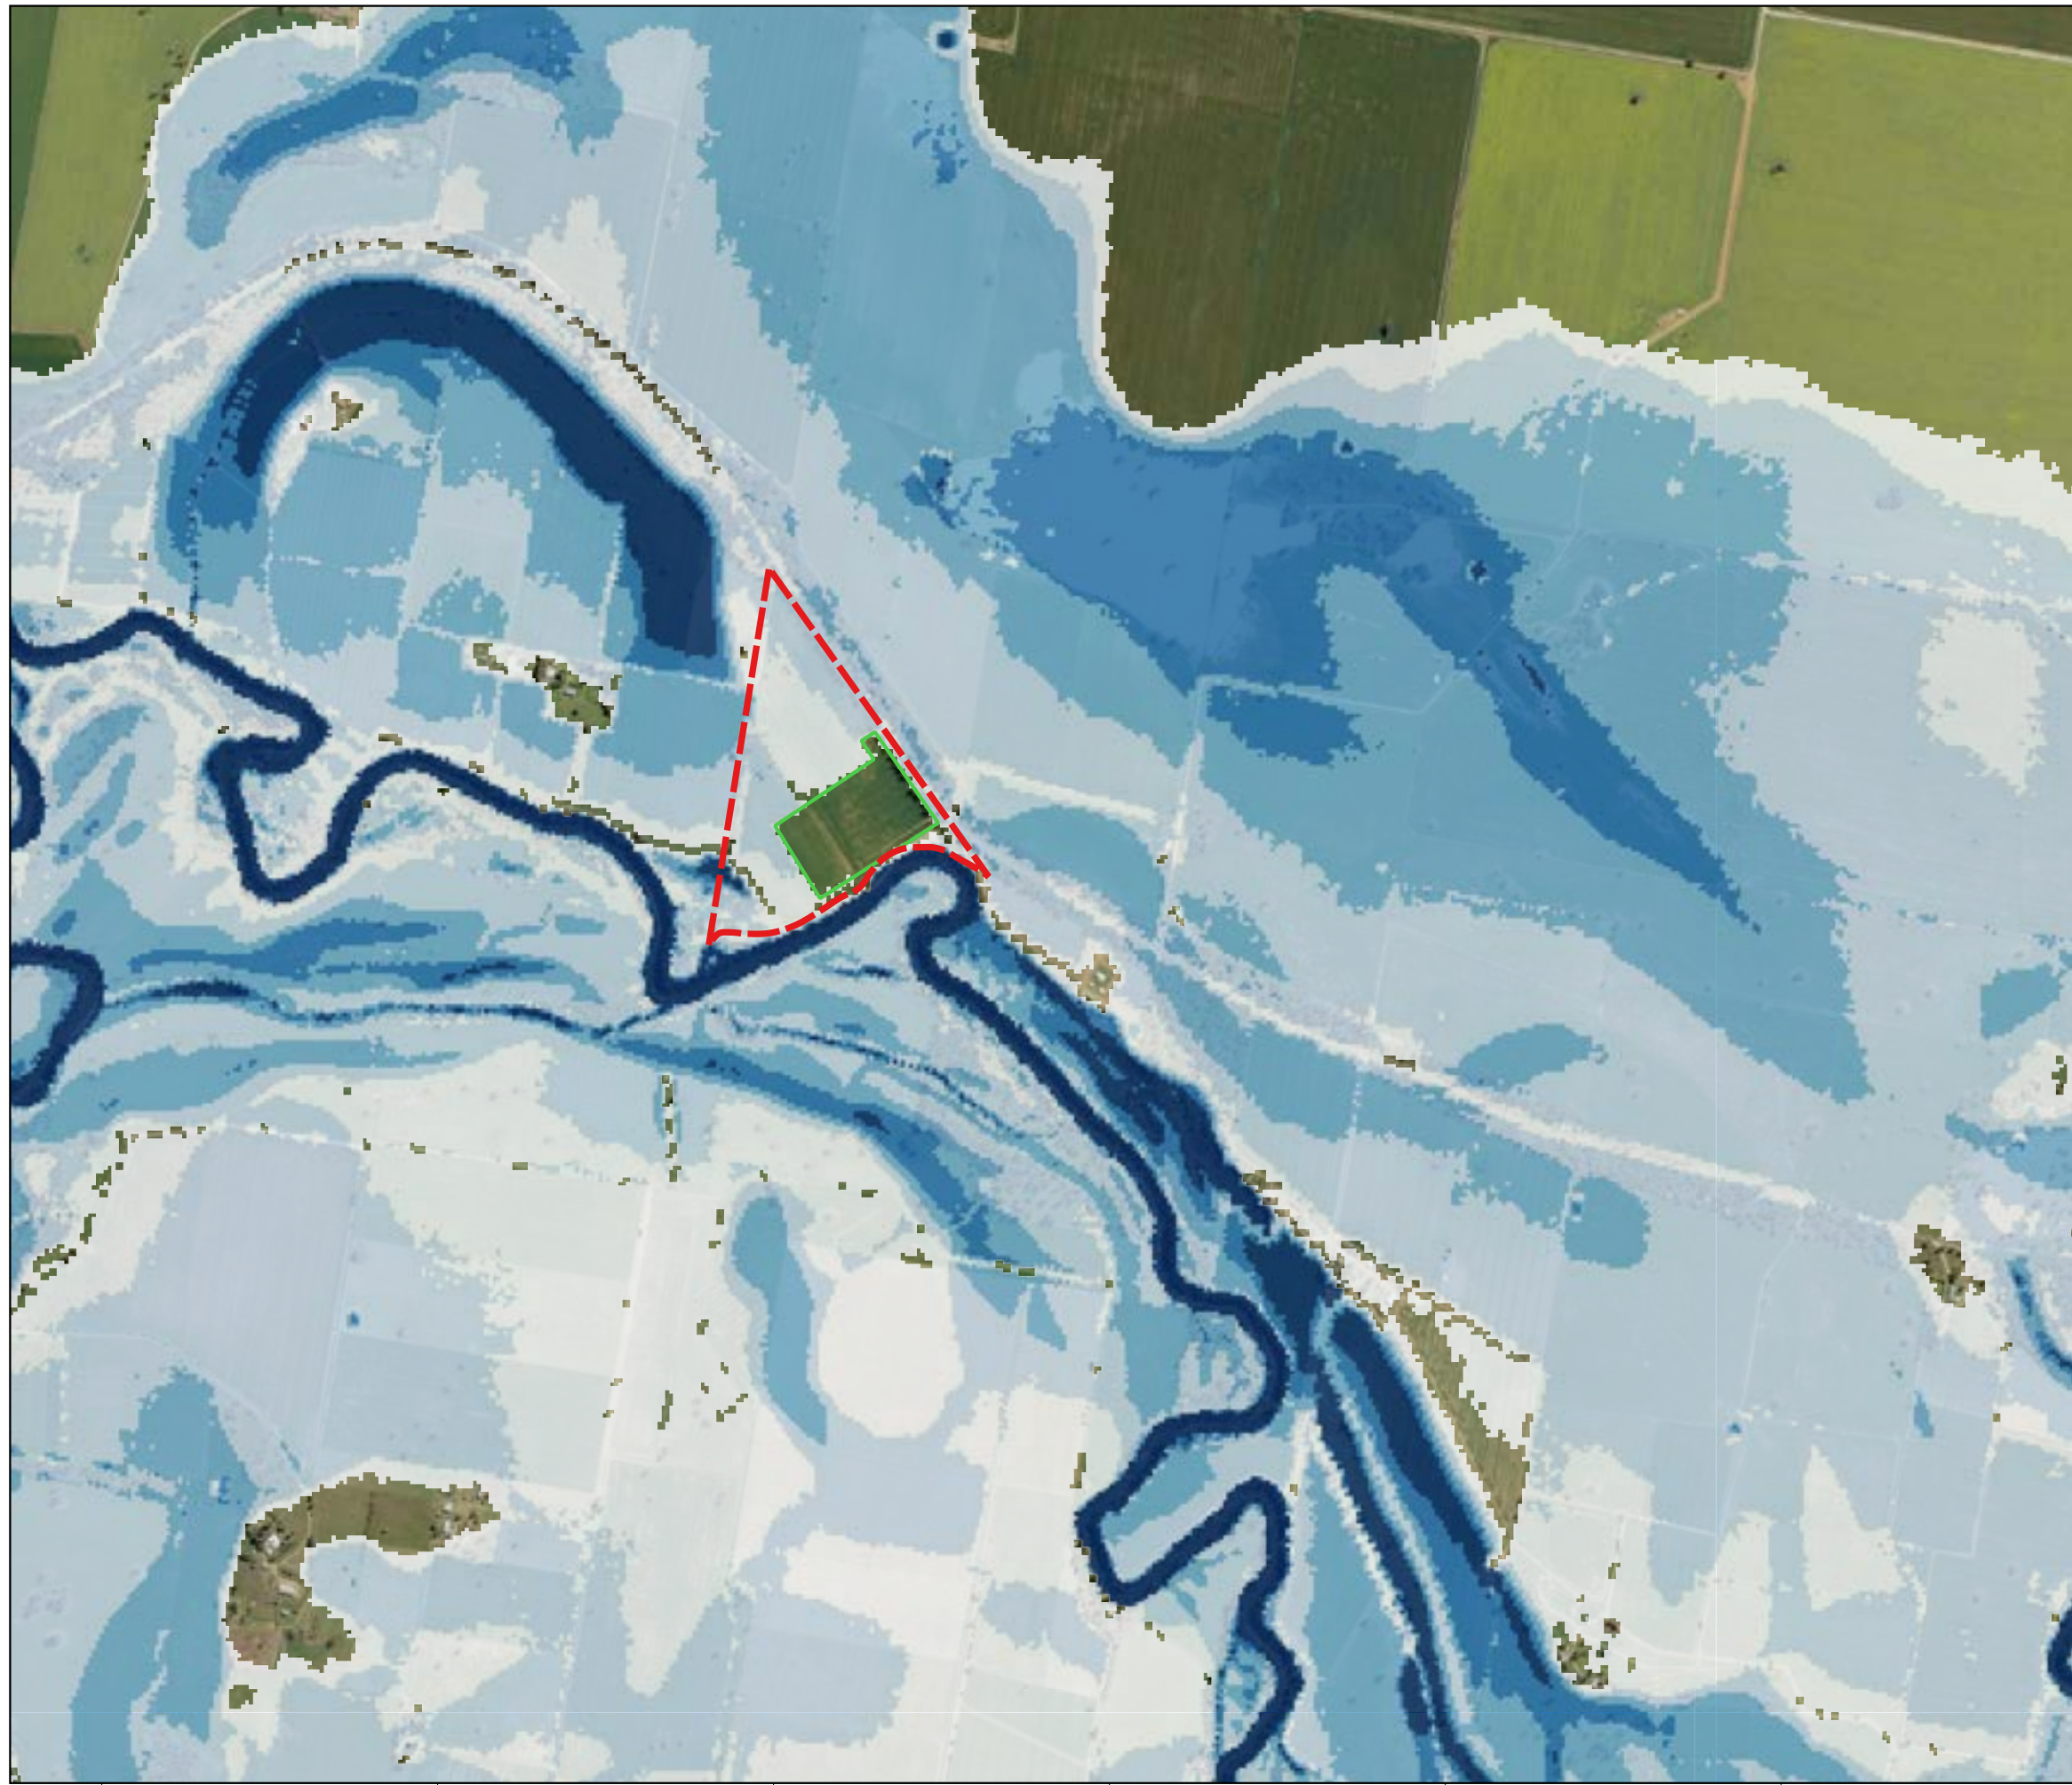
SE22026 Lachlan River Pre-Treatment Lagoons
 Figure 9
 Interim Scenario - Flood Depth 5% AEP
