REVIEW OF ENVIRONMENTAL FACTORS

Addendum #2 – Pre-treatment Plant Lachlan River Pre-Treatment Plant REF

PARKES SHIRE COUNCIL

Review of Environmental Factors – Addendum #2 Lachlan River Pre-treatment Plant

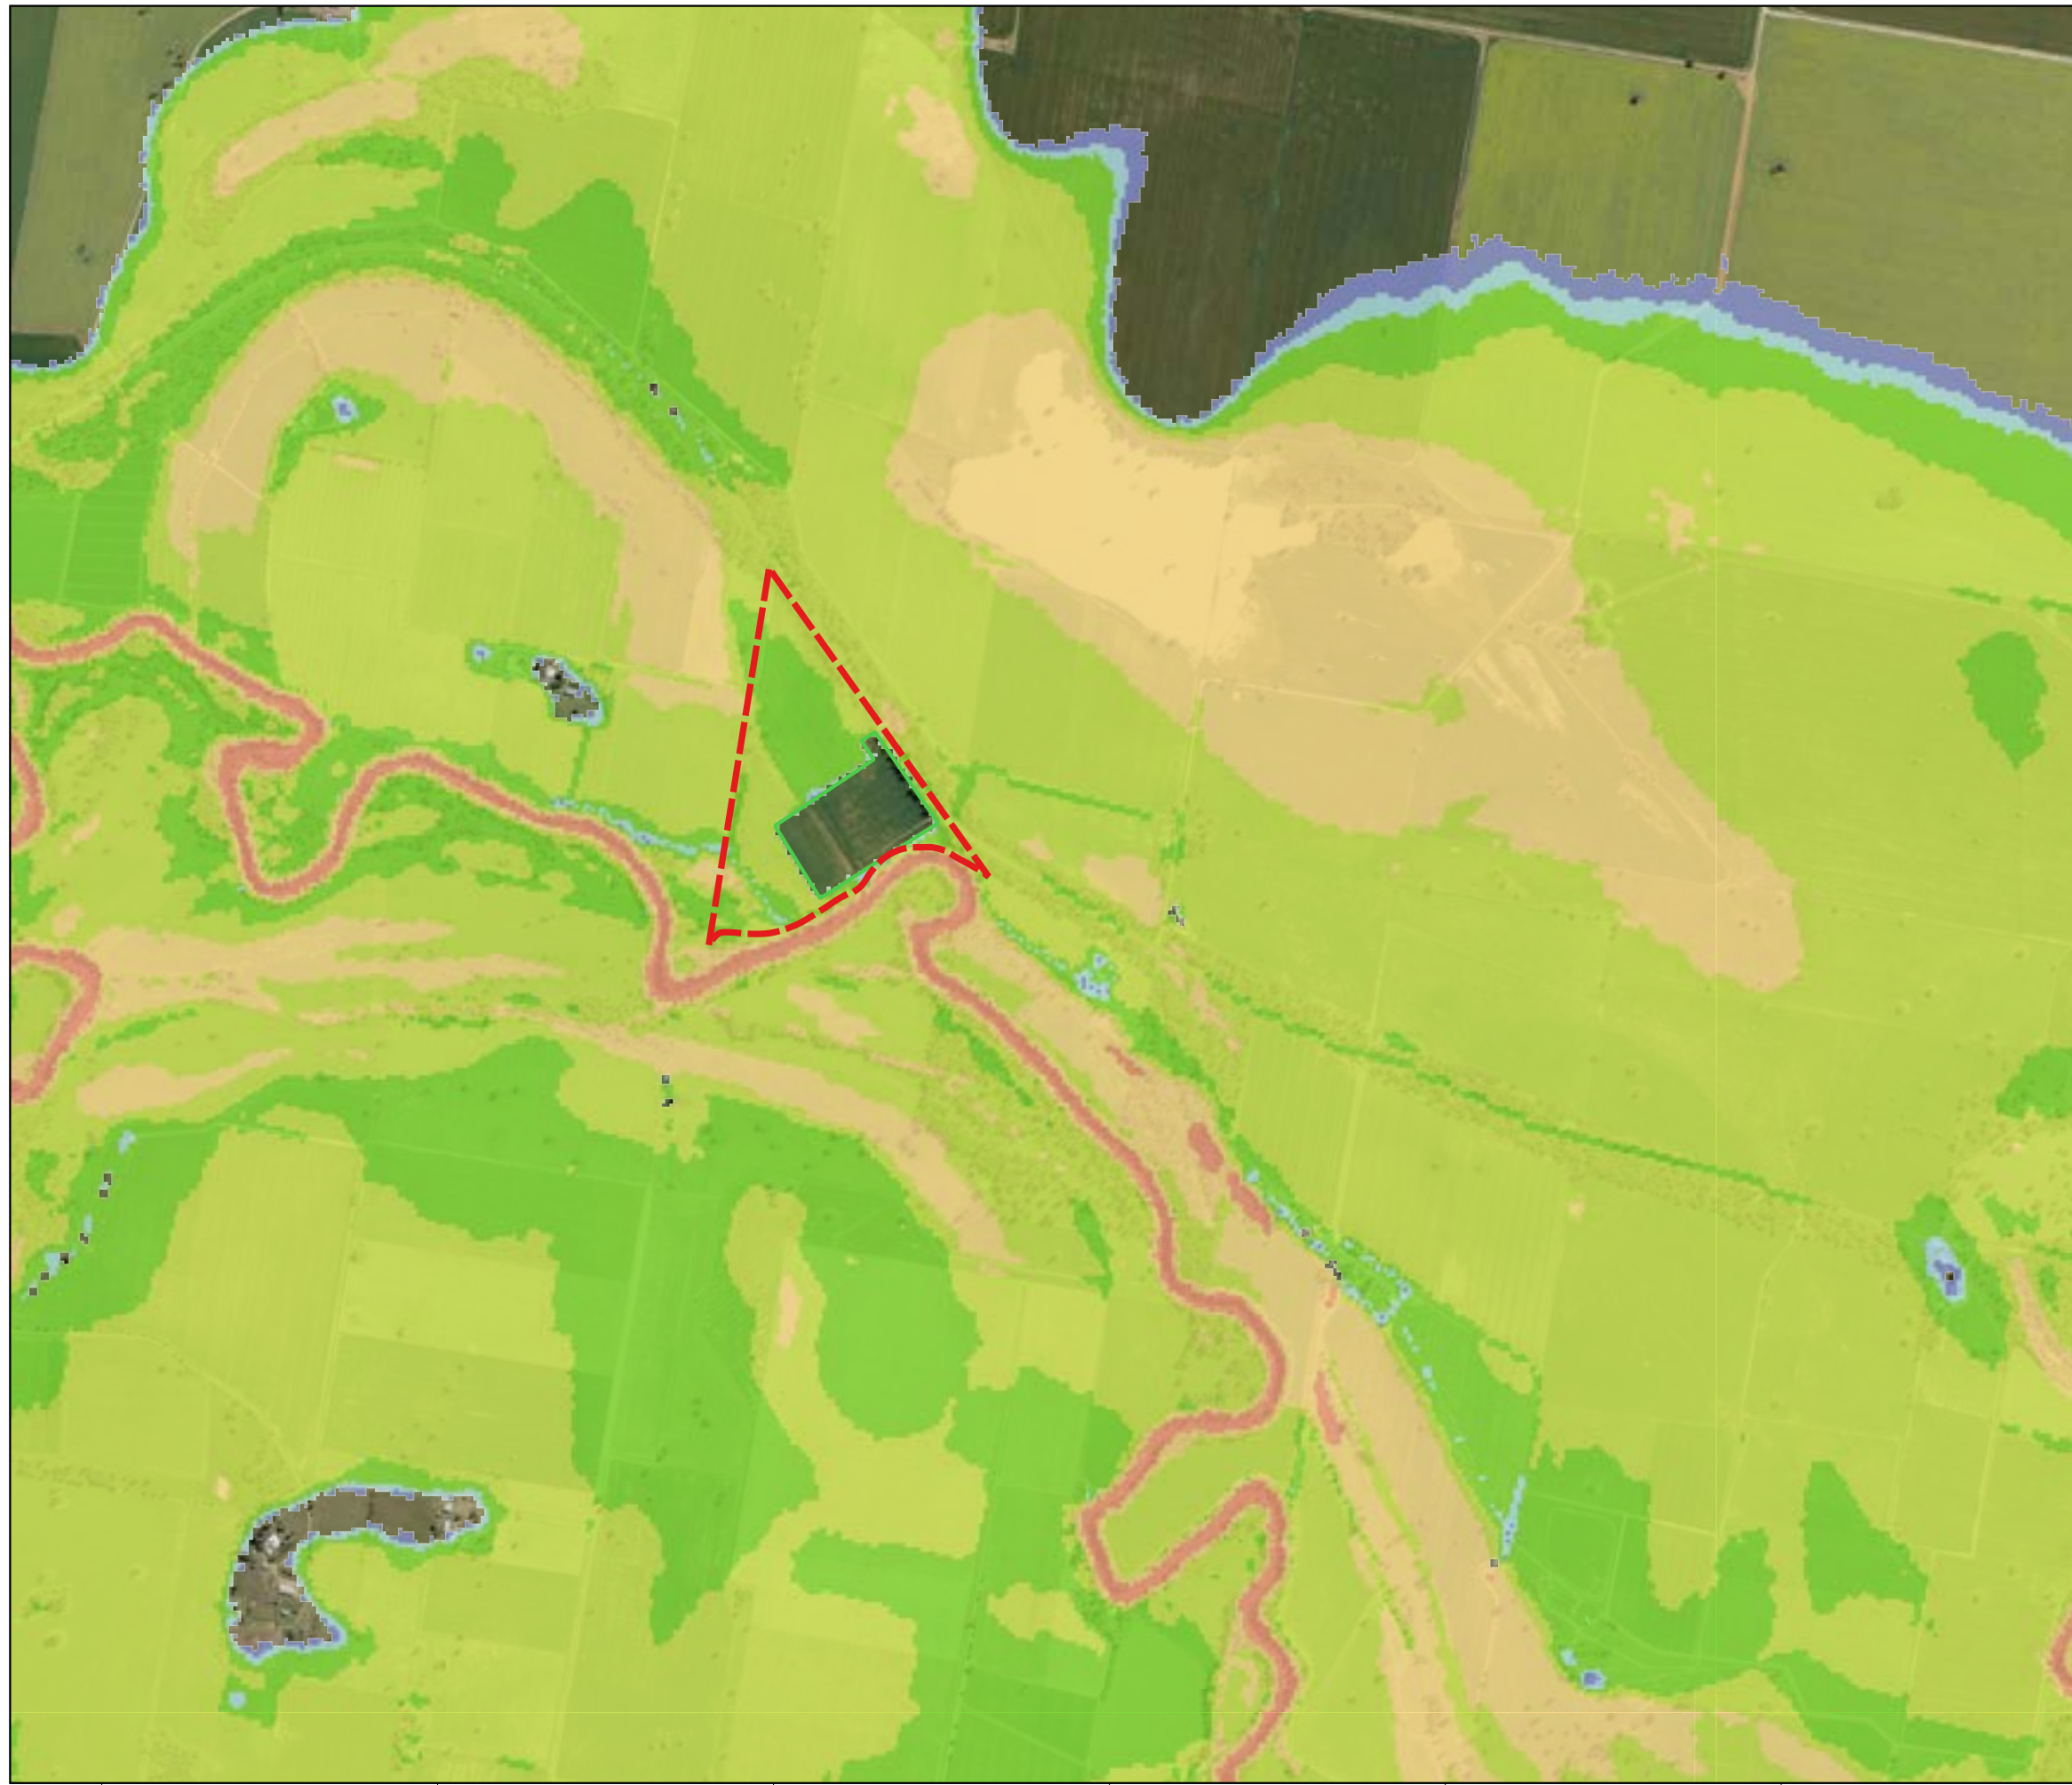
SE22026 Lachlan River Pre-Treatment Lagoons
 Figure 13
 Interim Scenario - Flood Hazard 1% AEP

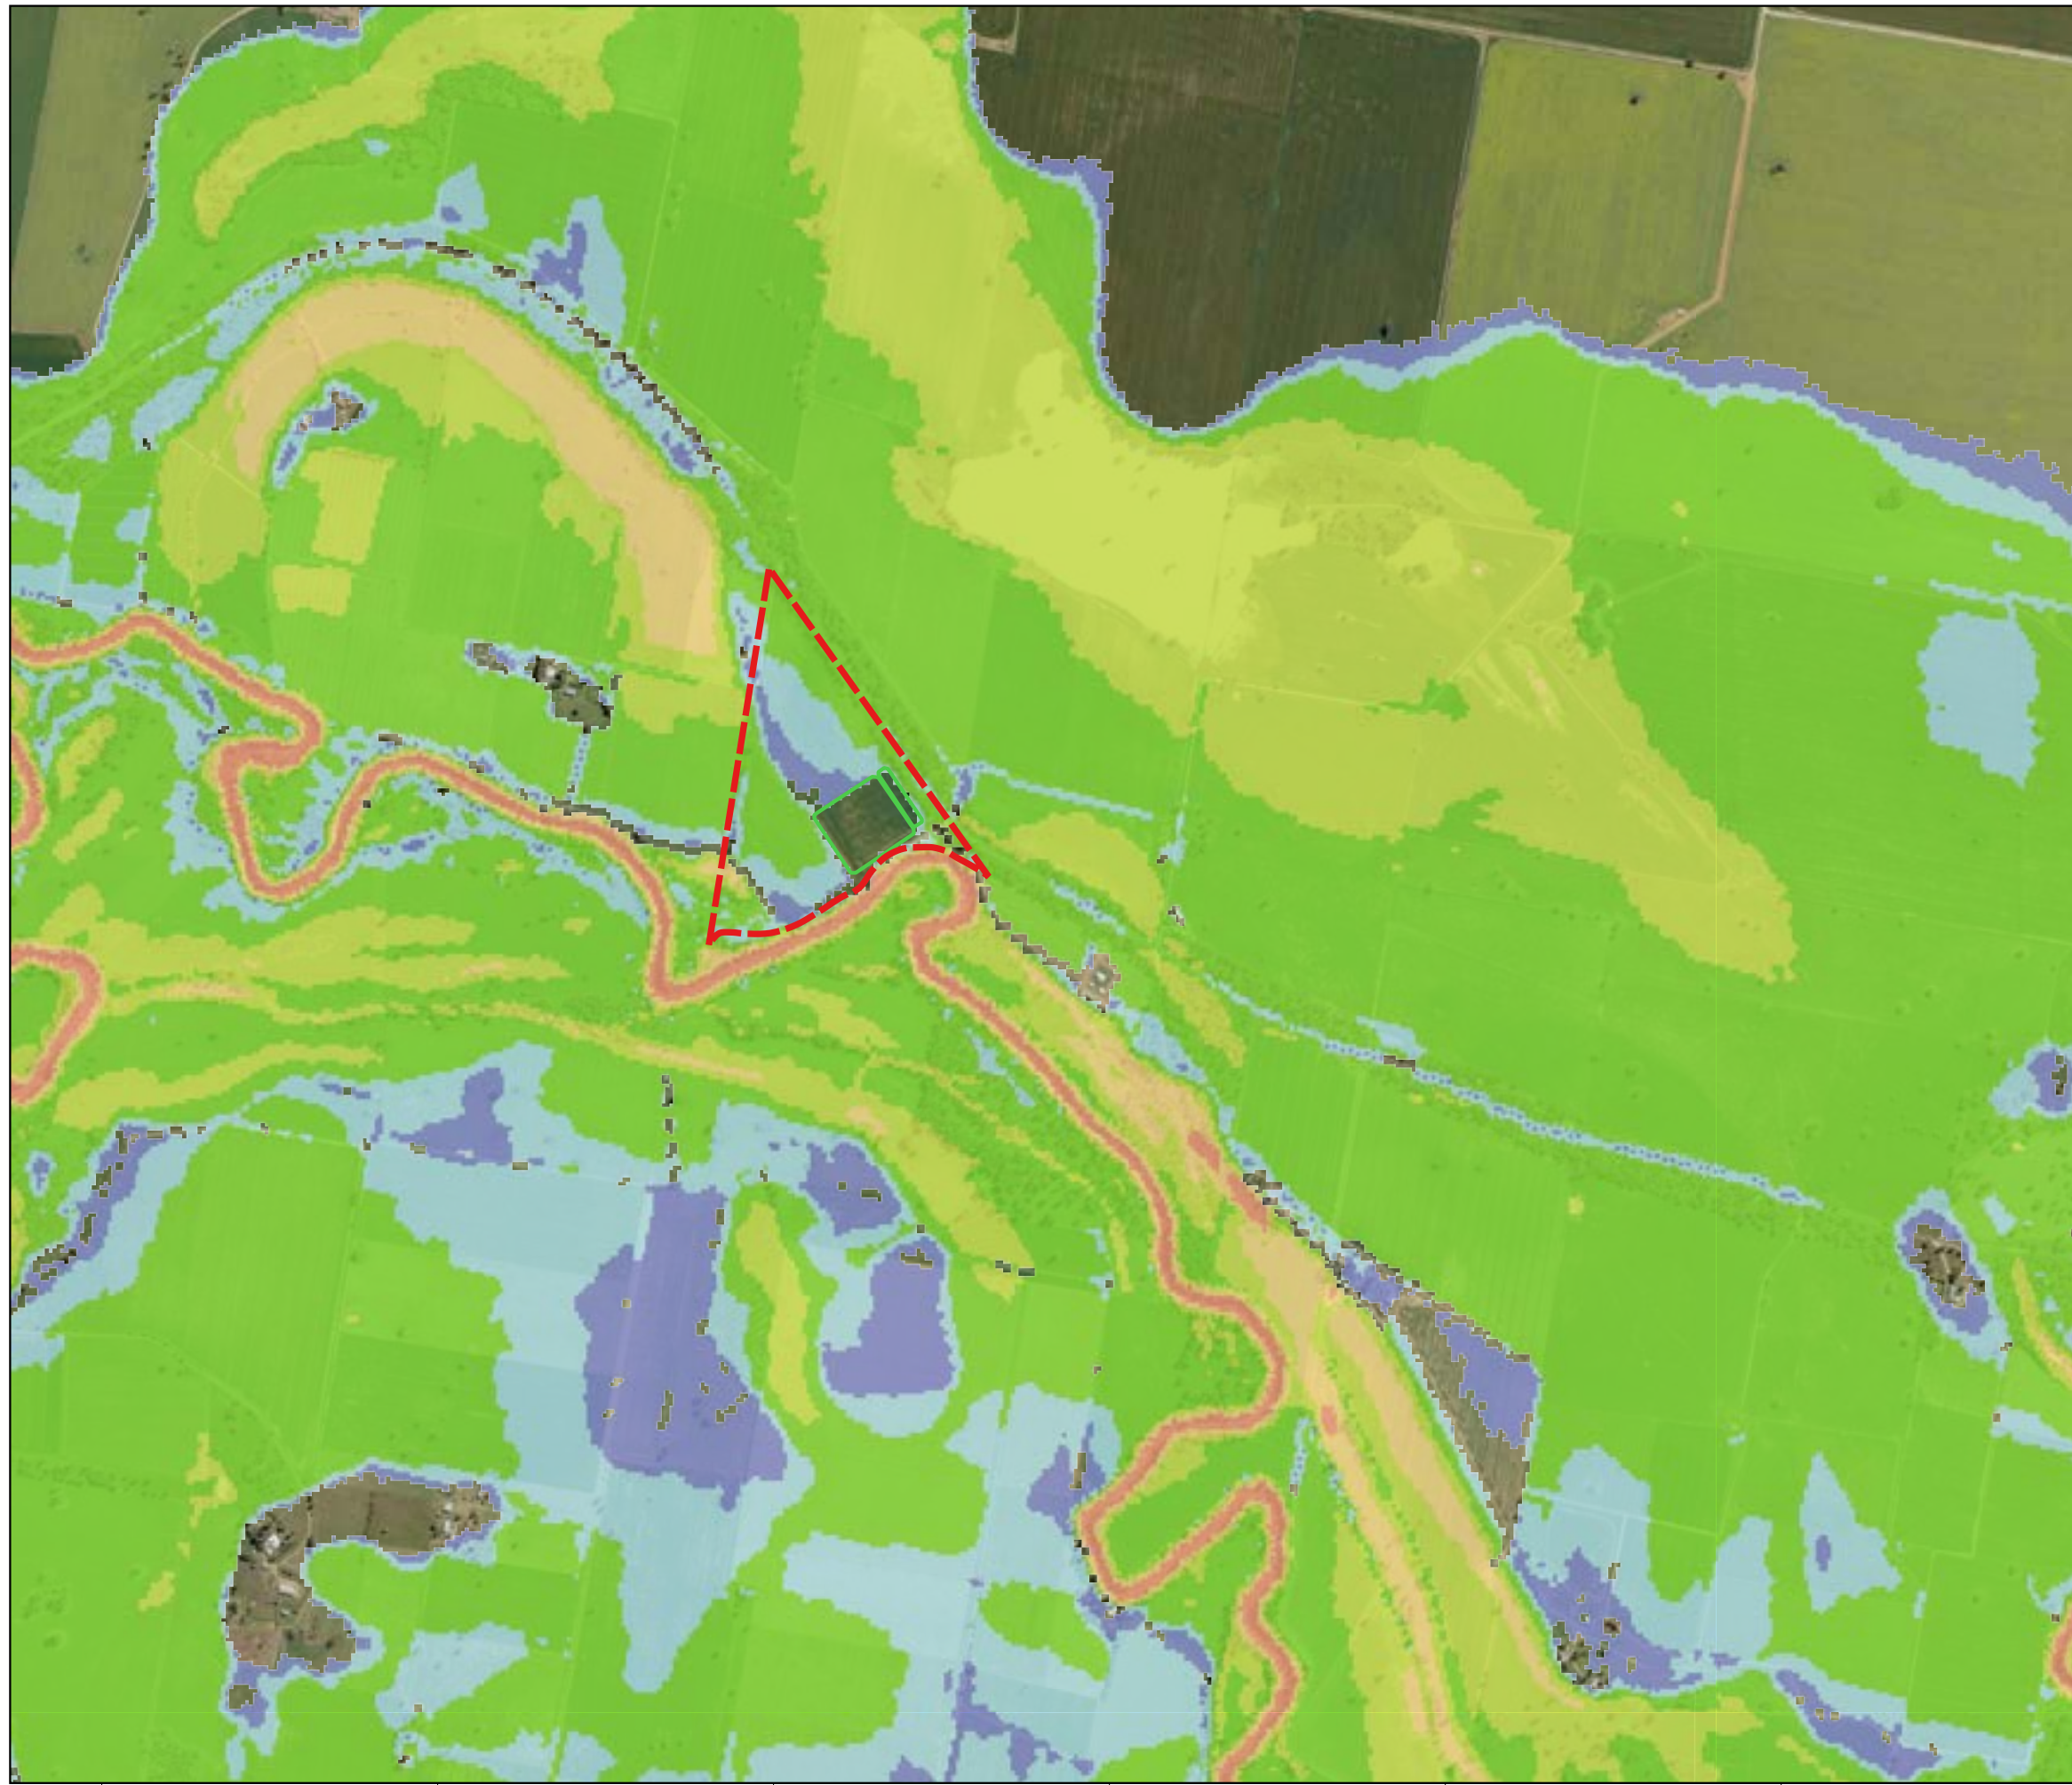
SE22026 Lachlan River Pre-Treatment Lagoons
 Figure 18
 Ultimate Scenario - Flood Hazard 5% AEP

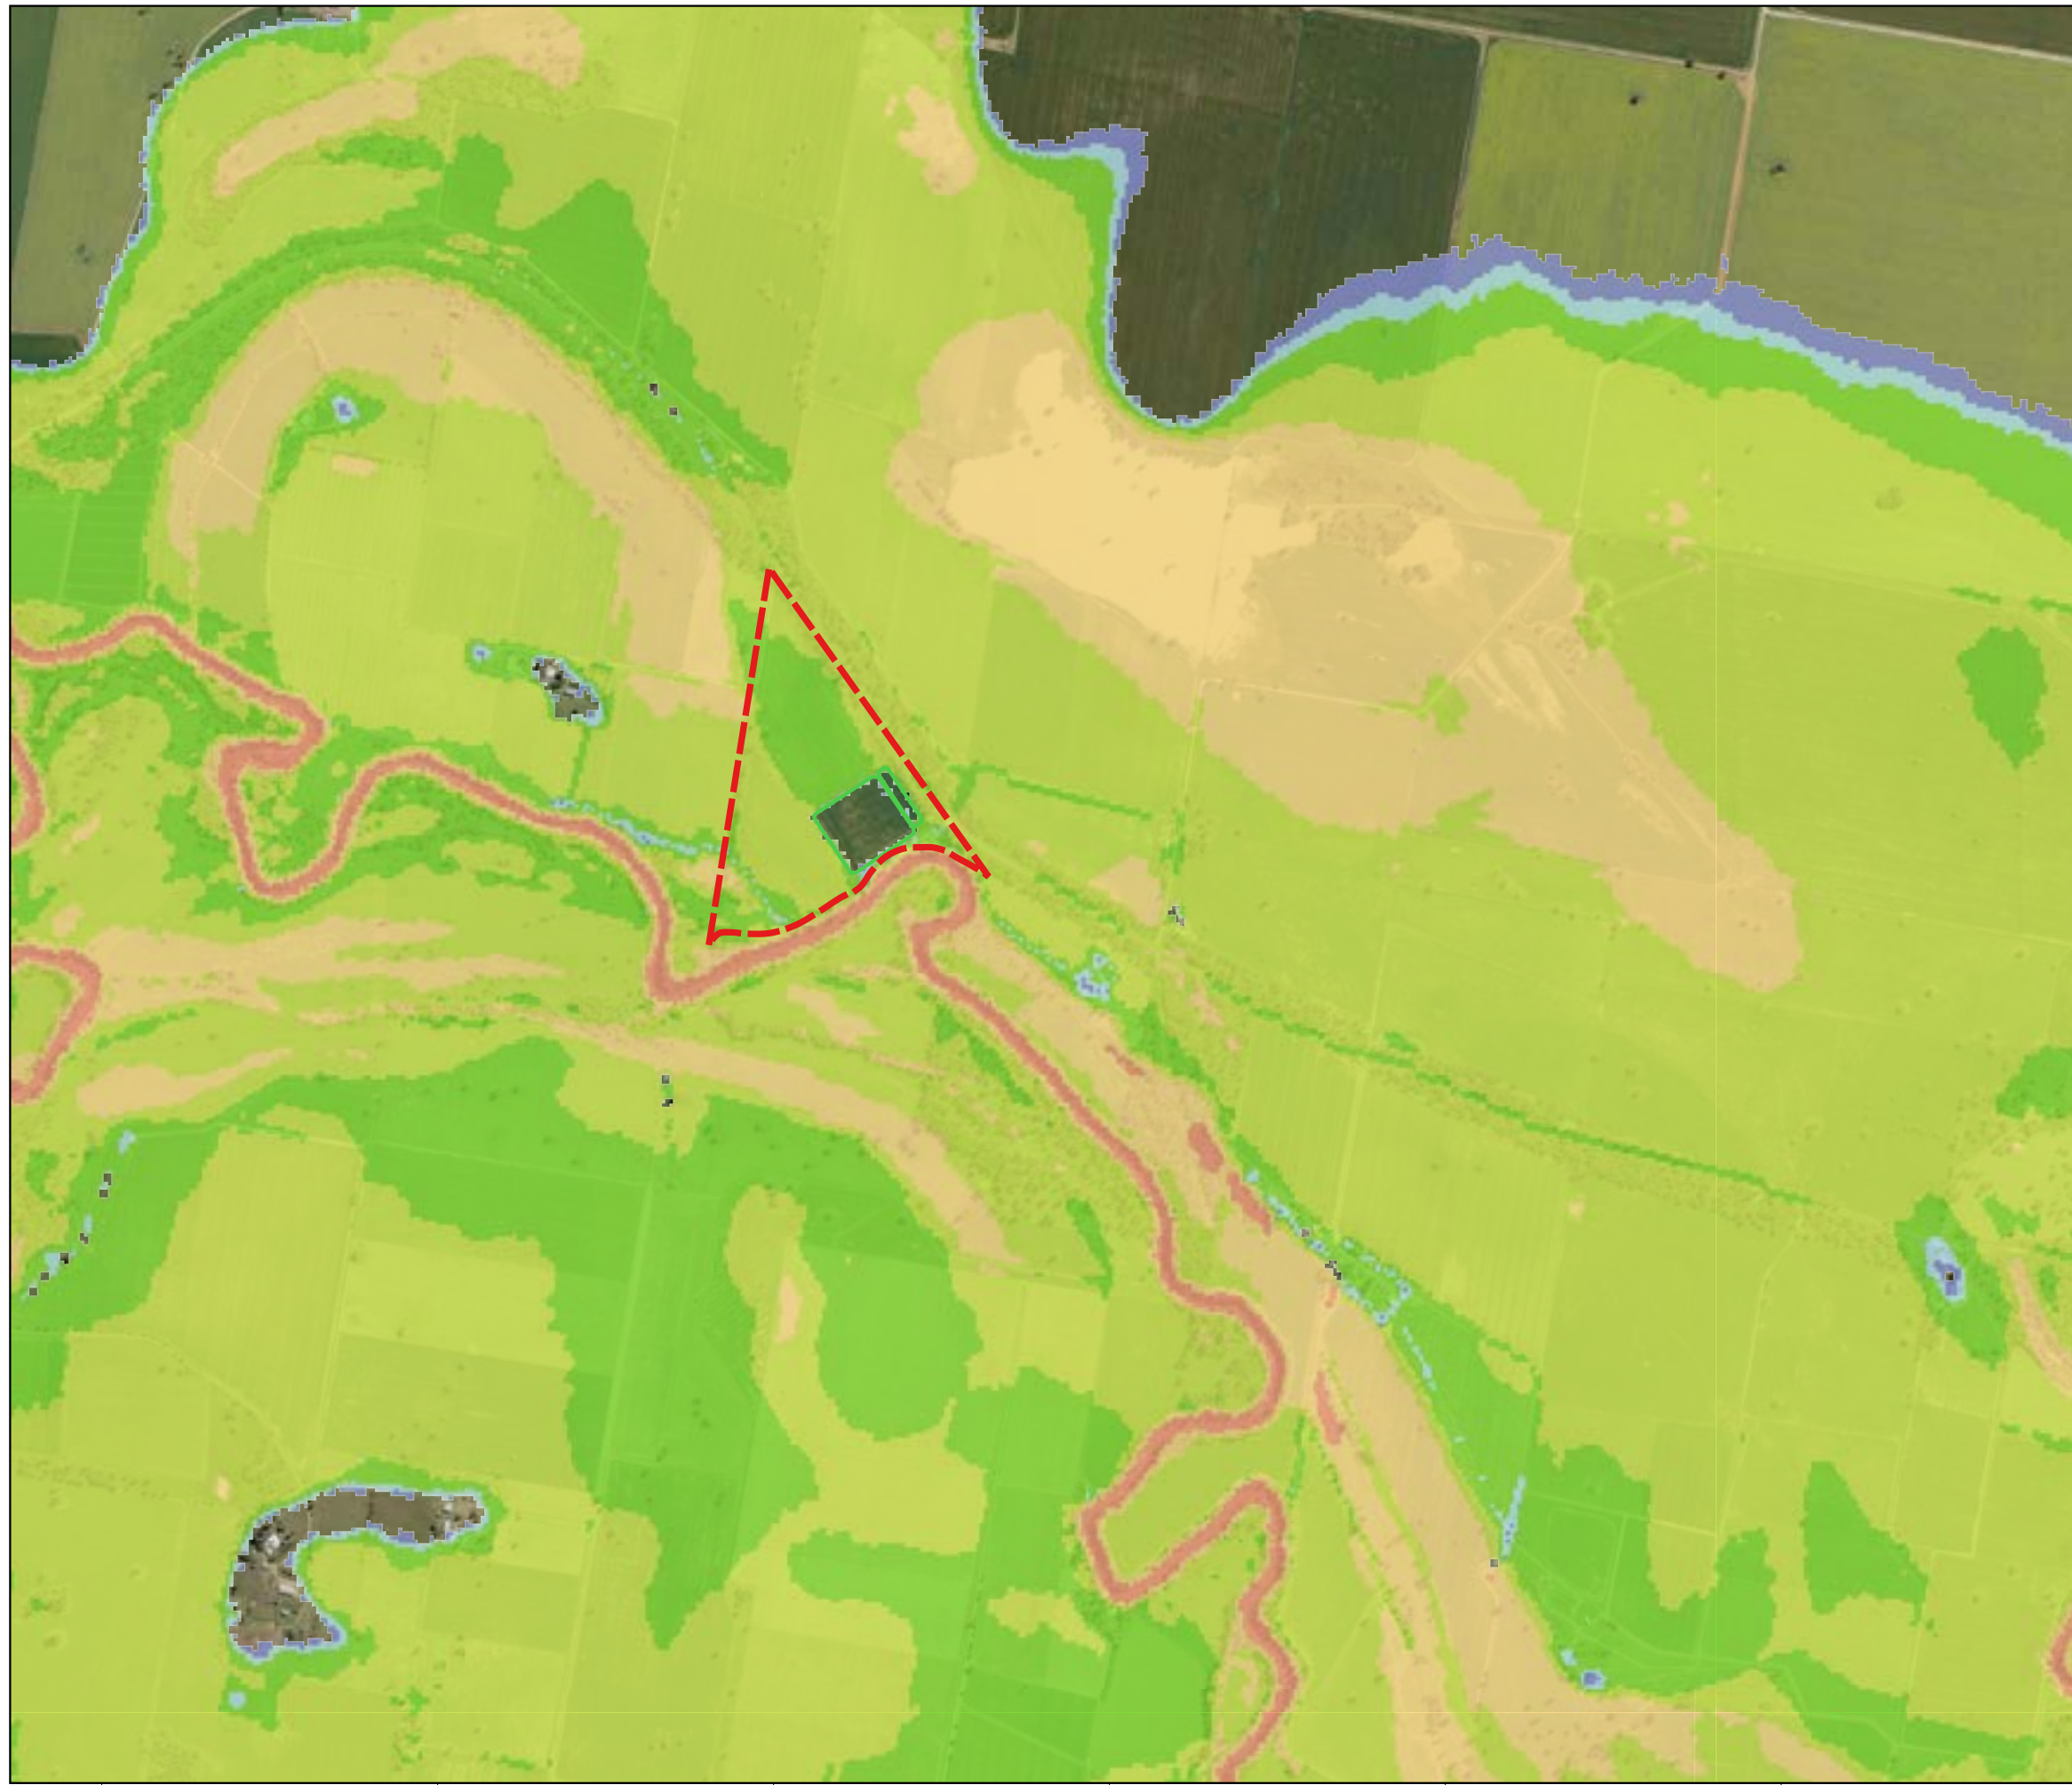
SE22026 Lachlan River Pre-Treatment Lagoons
 Figure 19
 Ultimate Scenario - Flood Hazard 1% AEP

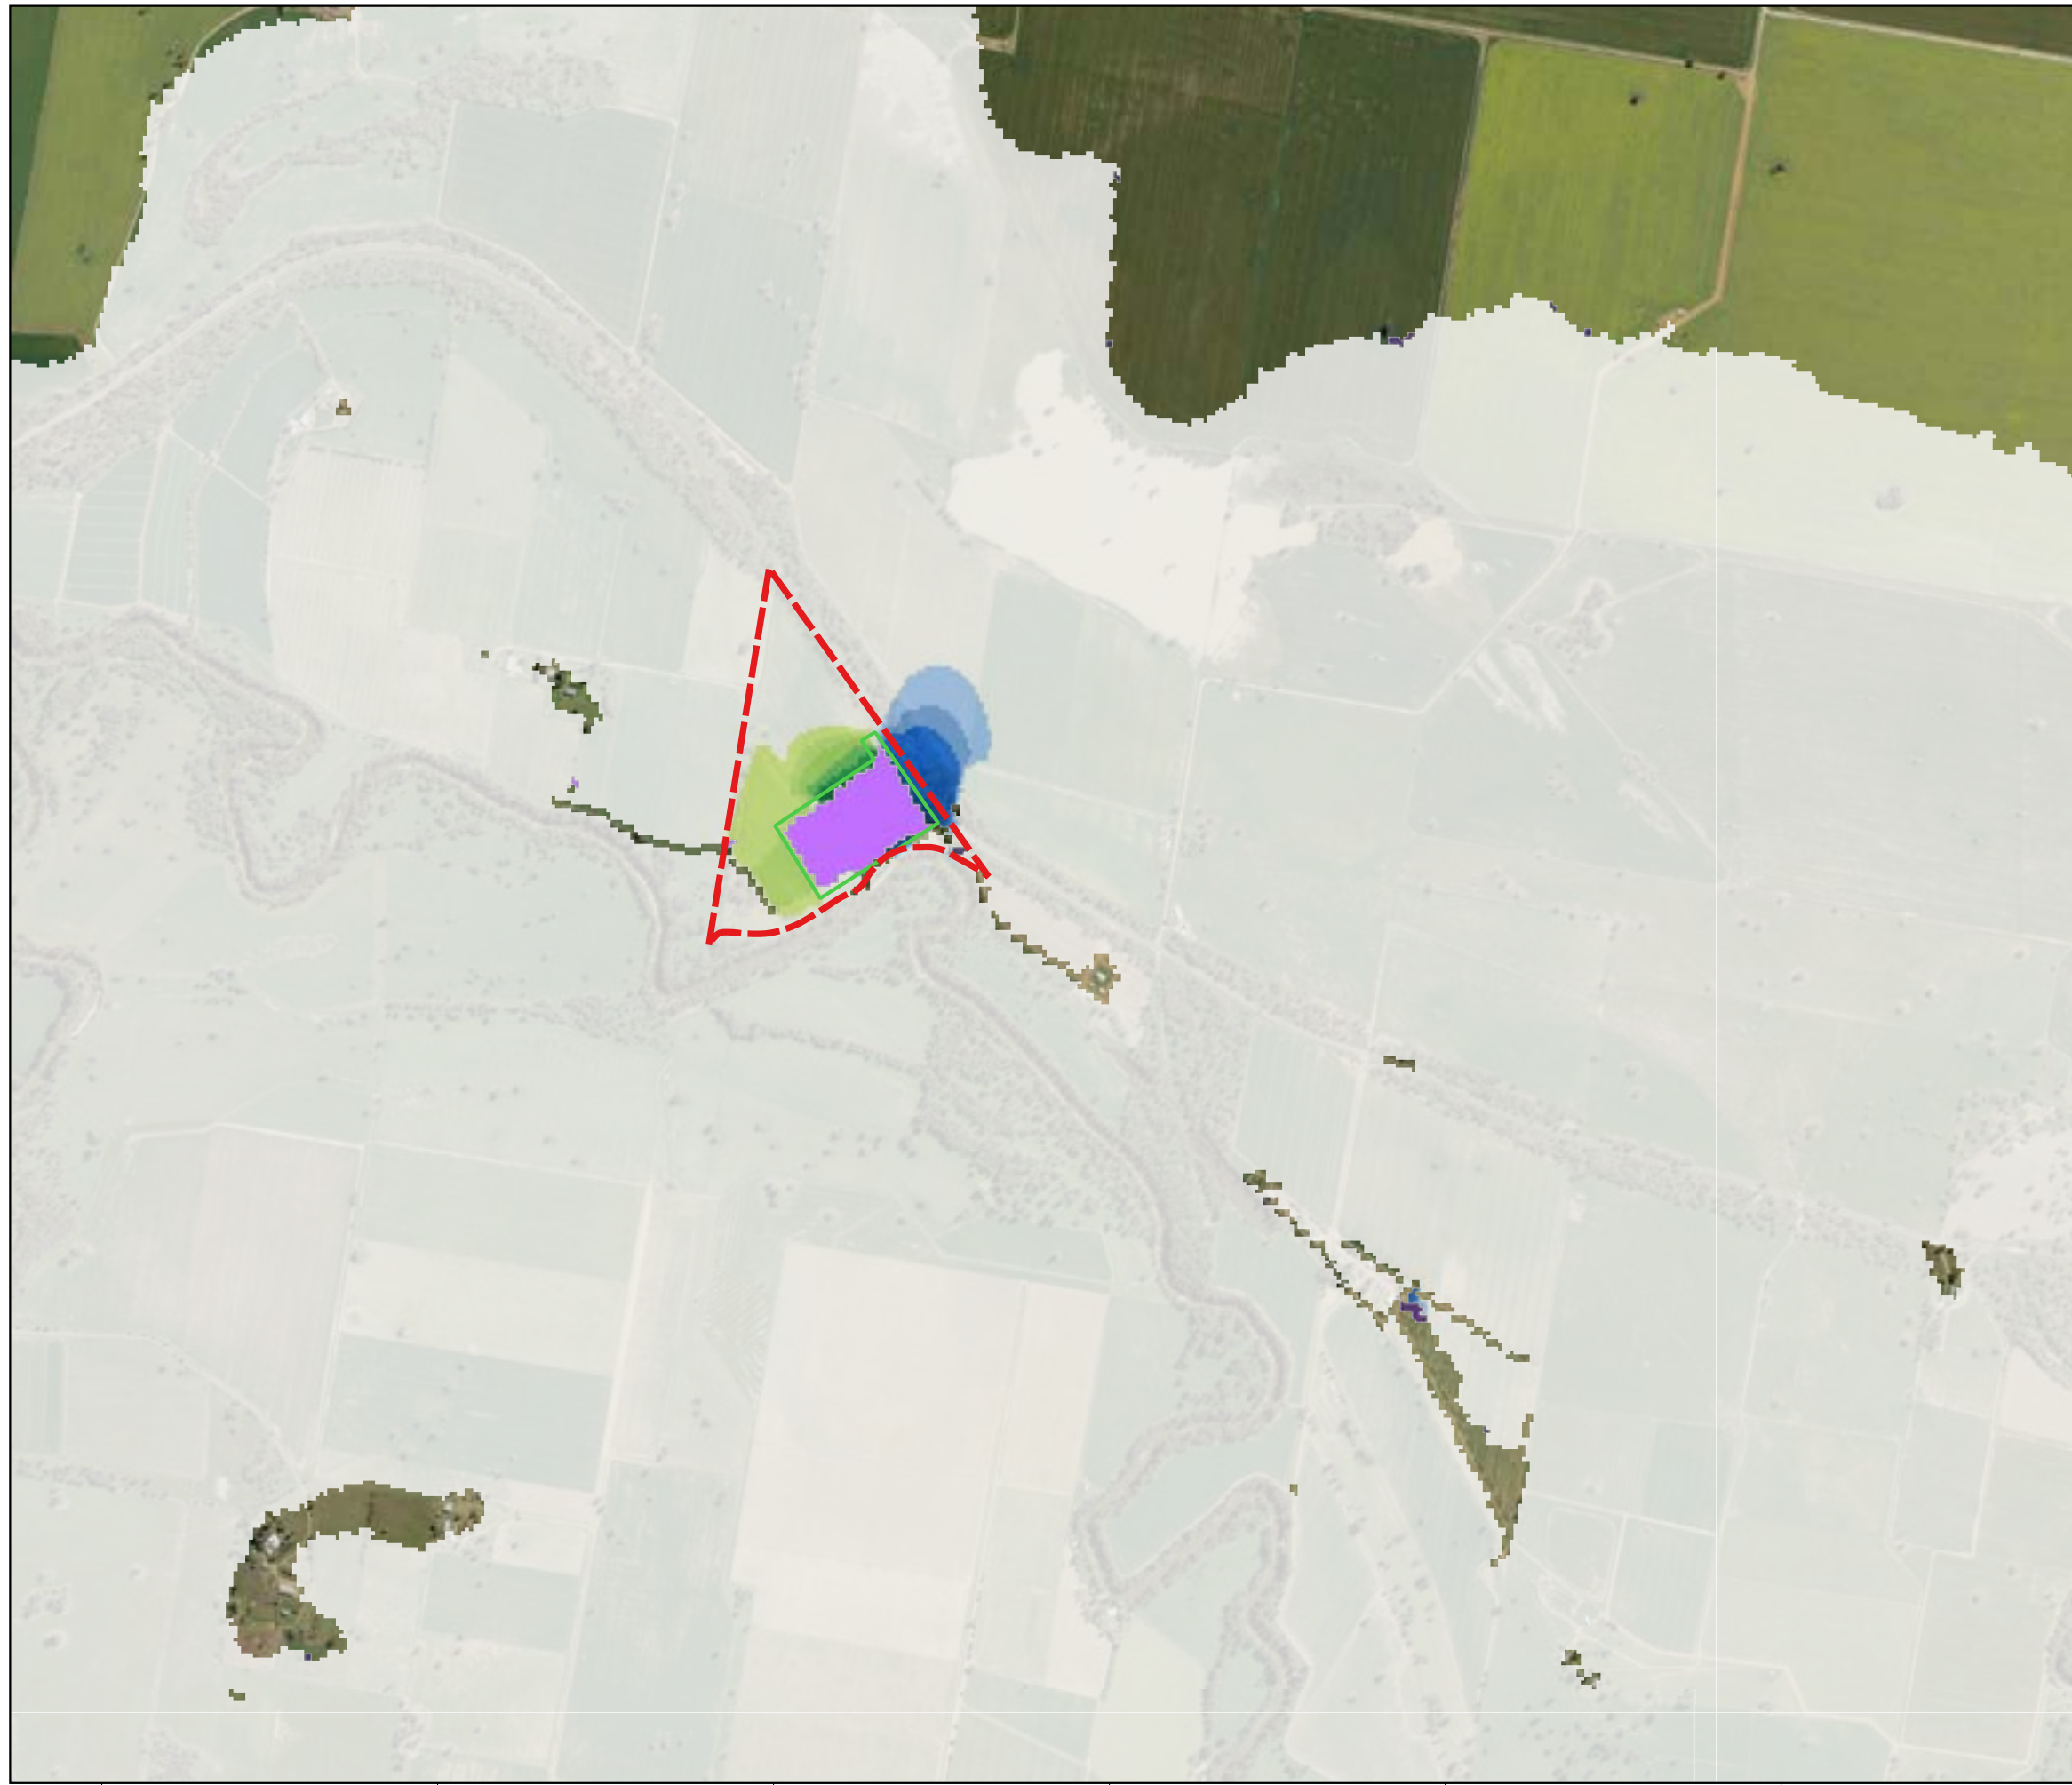
SE22026 Lachlan River Pre-Treatment Lagoons
 Figure 21
 Afflux Interim Scenario - 5% AEP

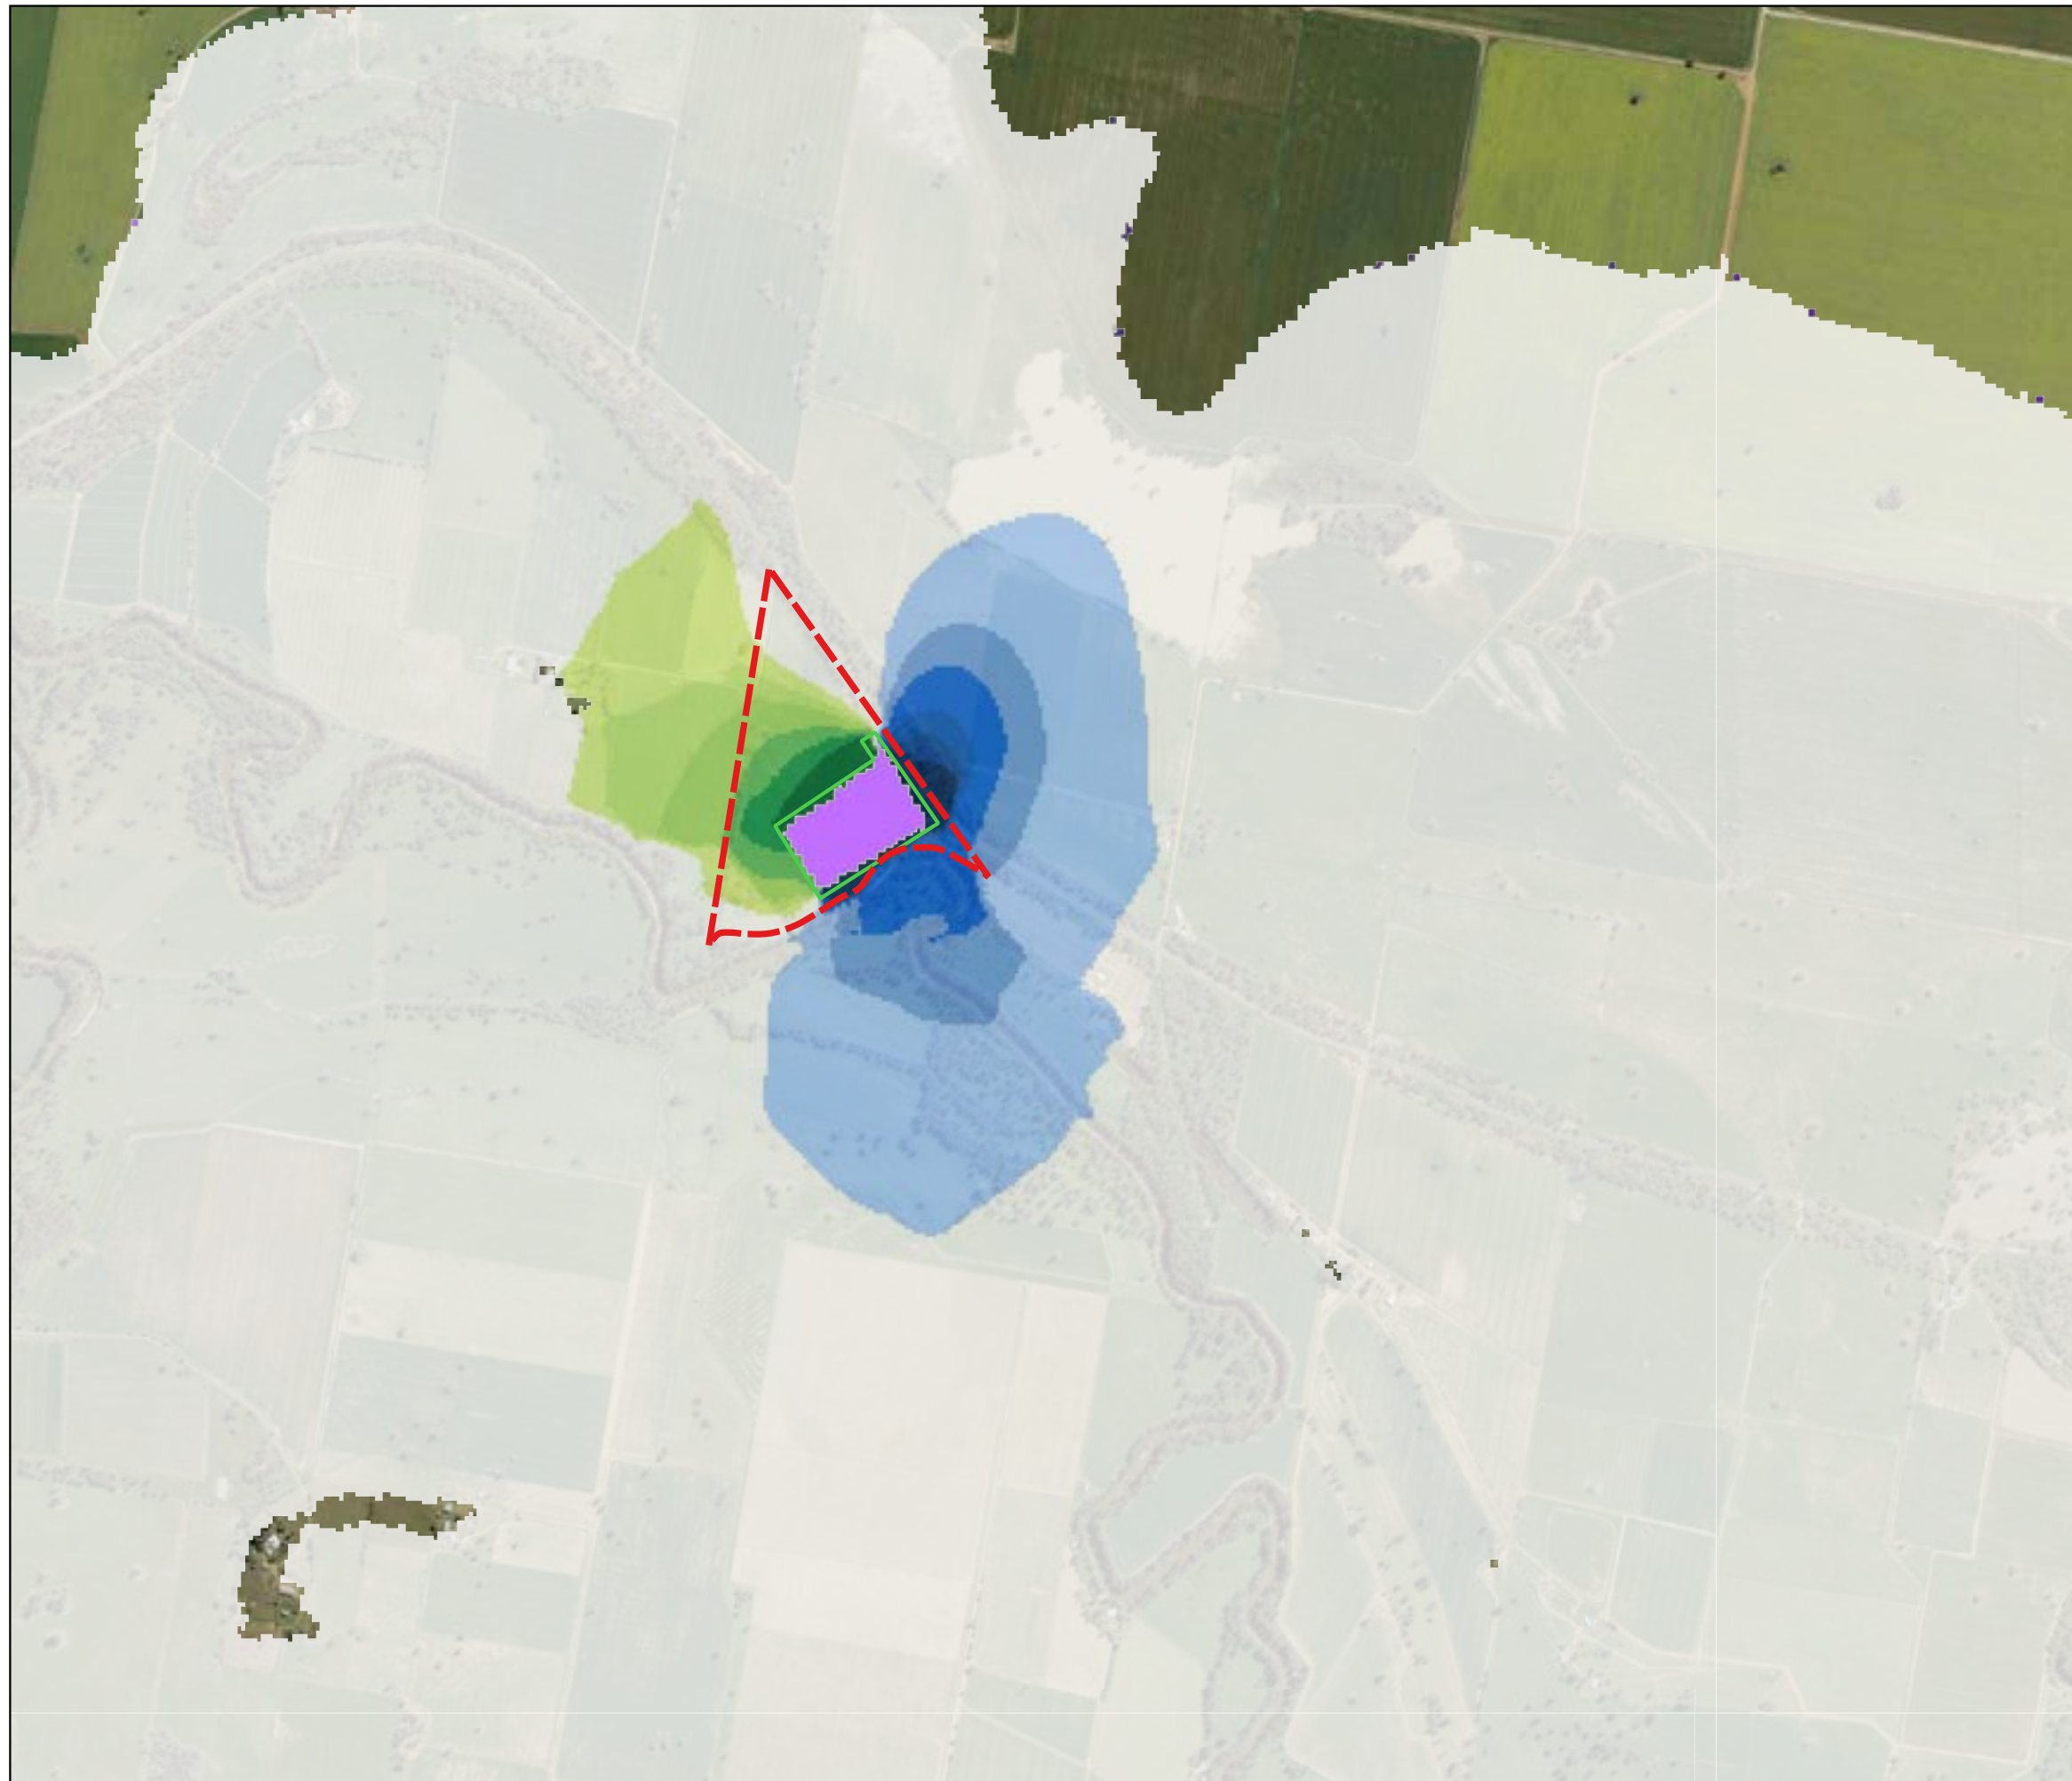
Figure 22
 Afflux Interim Scenario - 1% AEP

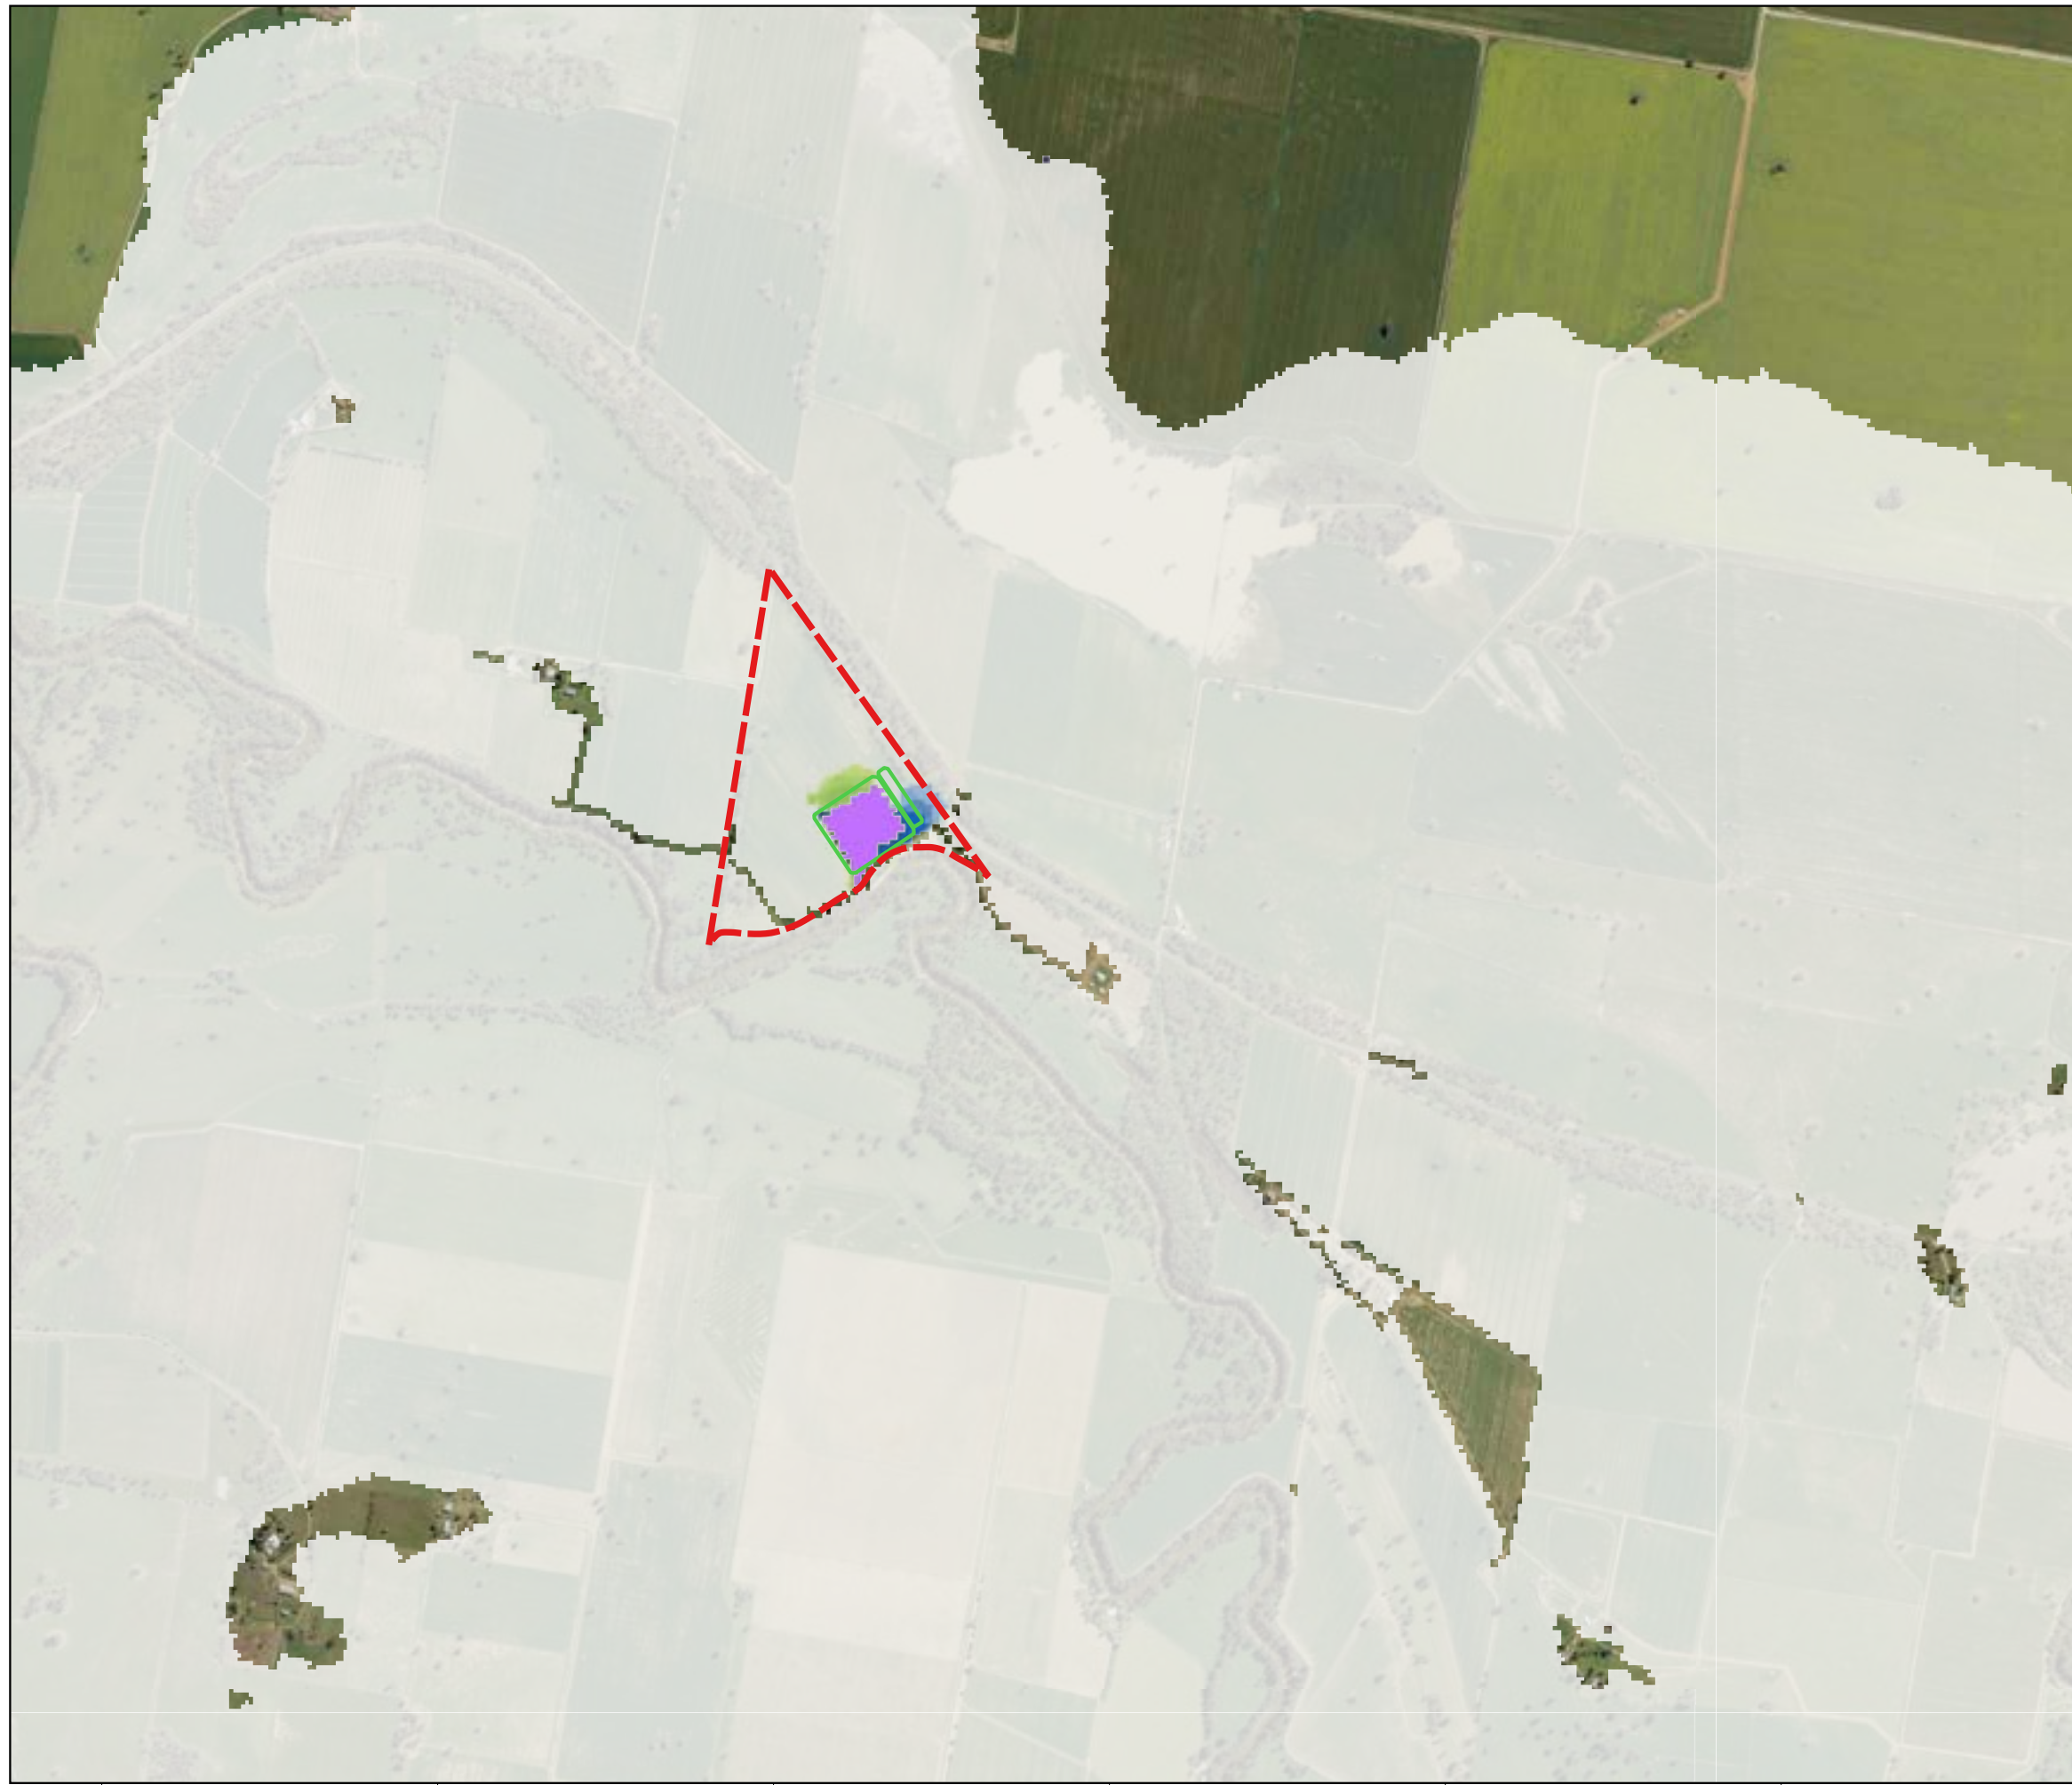
SE22026 Lachlan River Pre-Treatment Lagoons
 Figure 23
 Afflux Ultimate Scenario - 10% AEP
