REVIEW OF ENVIRONMENTAL FACTORS

Addendum #2 – Pre-treatment Plant Lachlan River Pre-Treatment Plant REF

PARKES SHIRE COUNCIL

Review of Environmental Factors – Addendum #2 Lachlan River Pre-treatment Plant

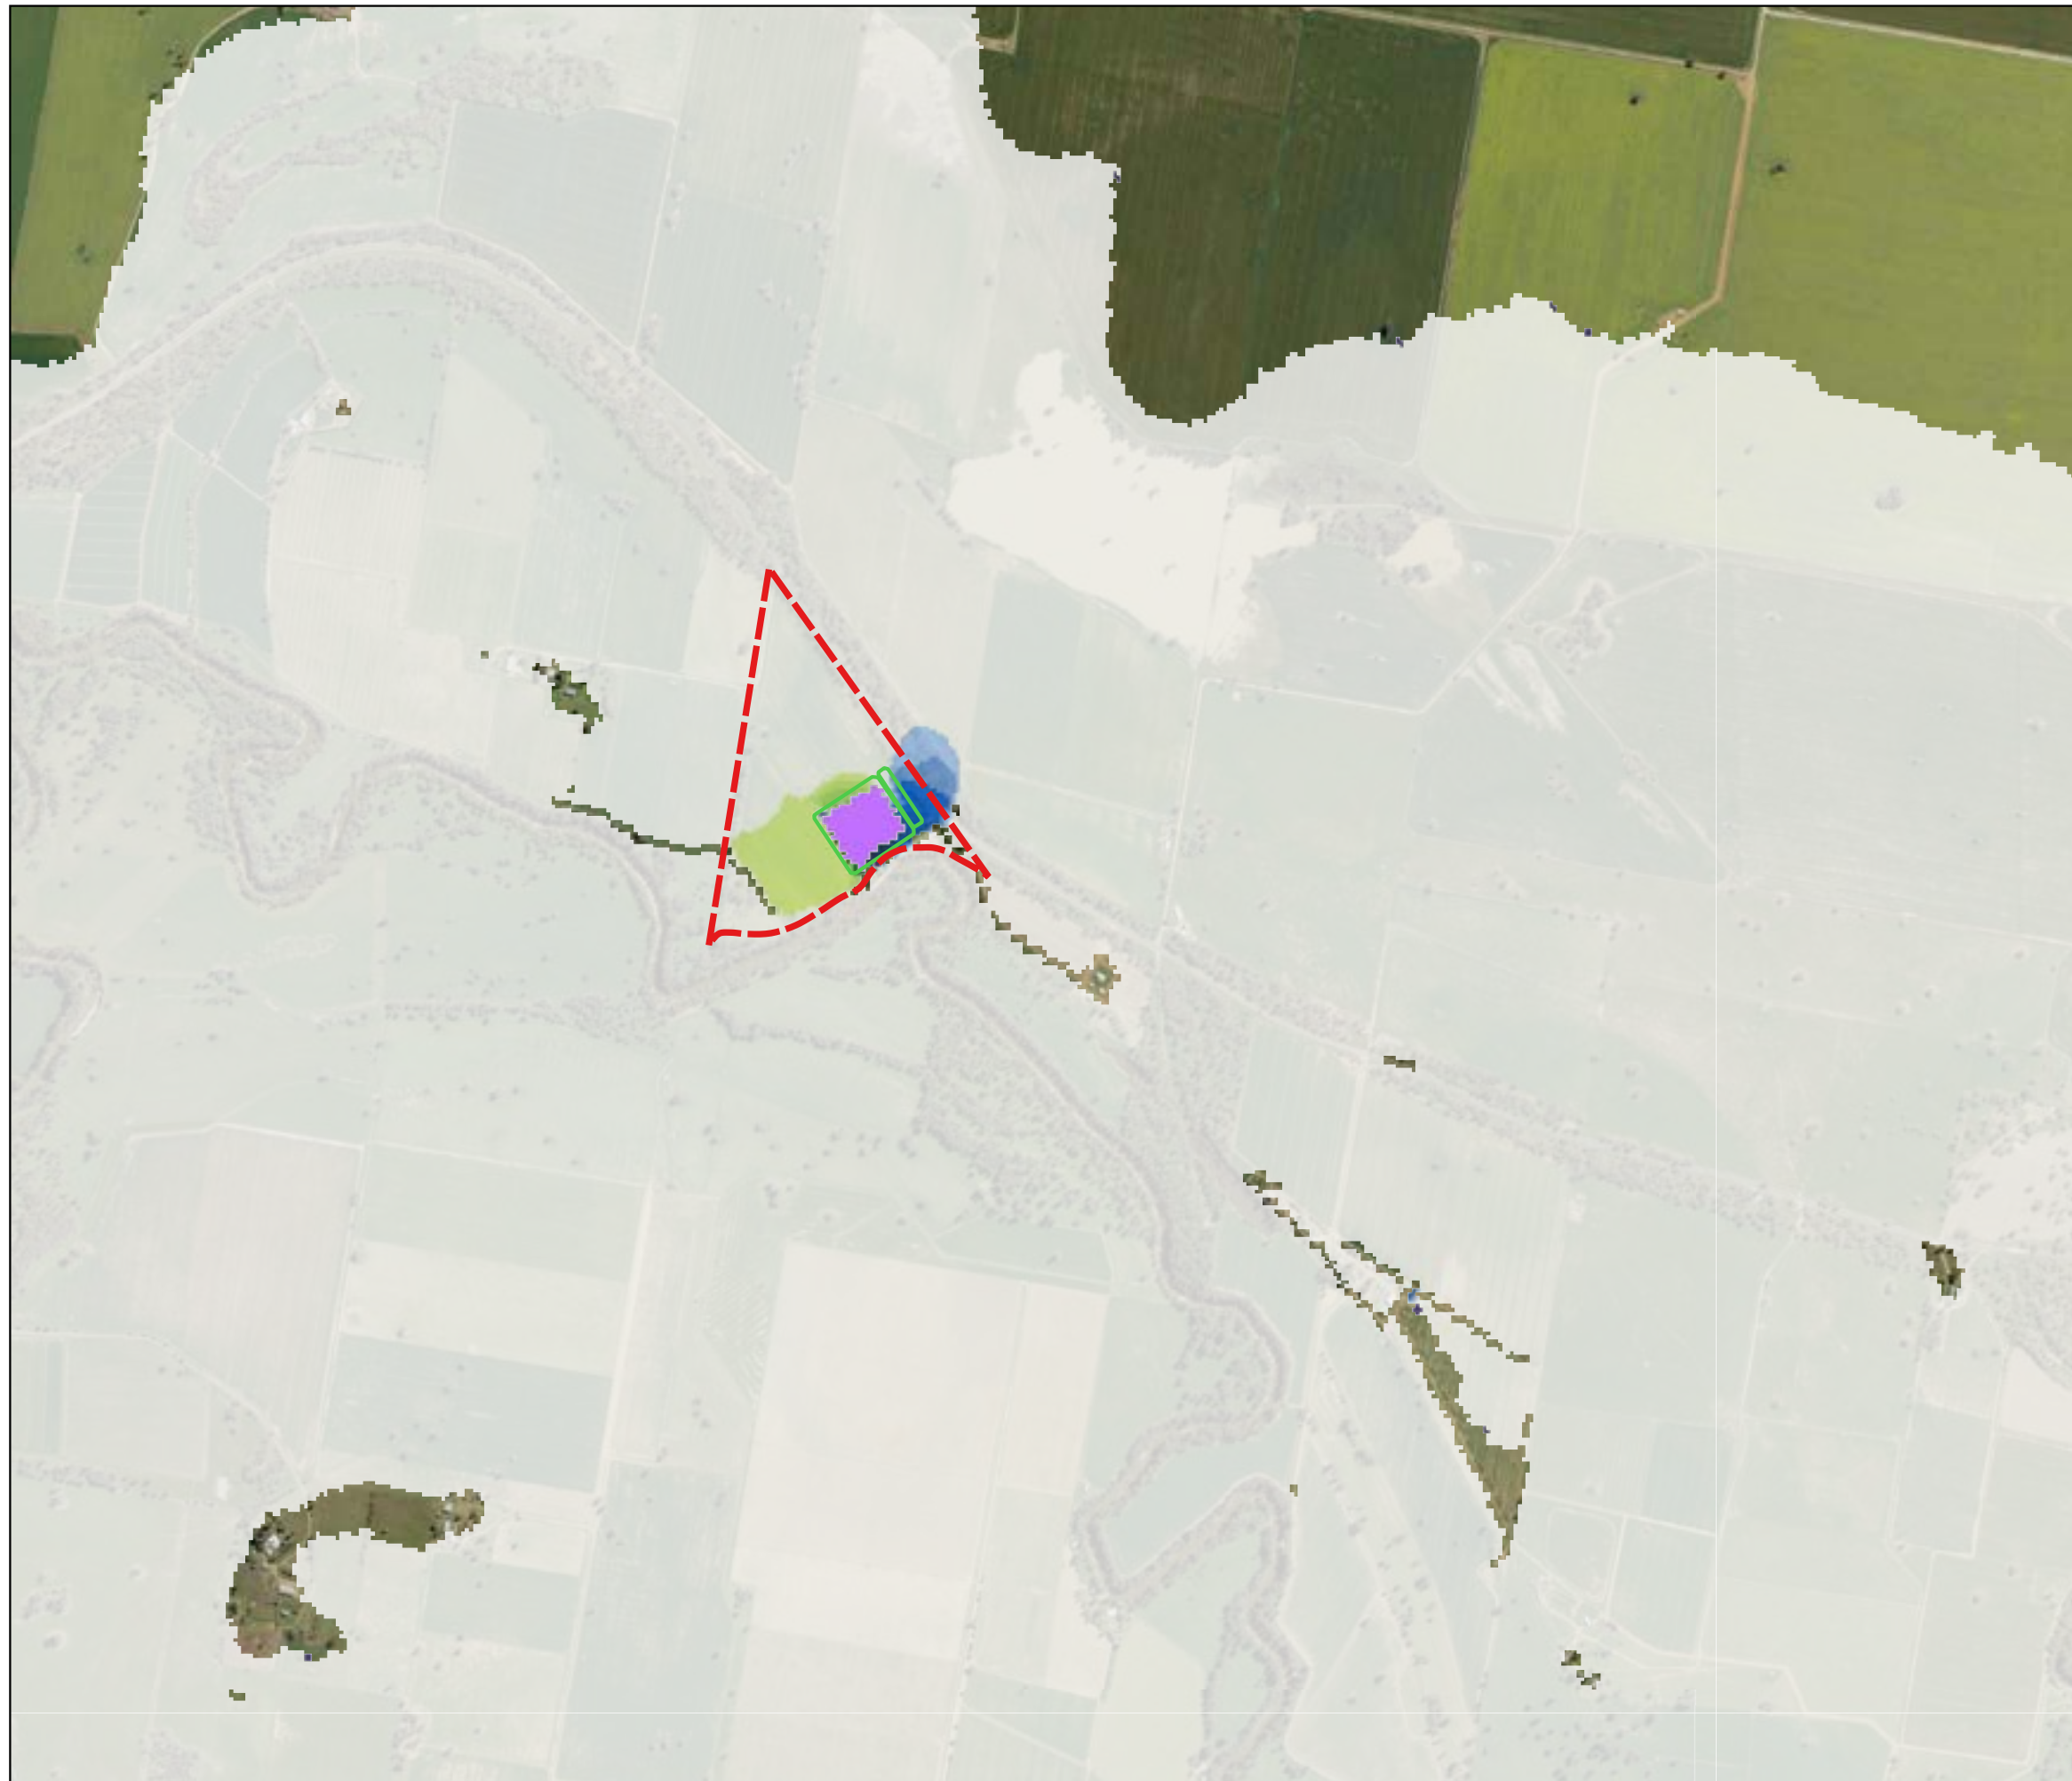
SE22026 Lachlan River Pre-Treatment Lagoons
 Figure 24
 Afflux Ultimate Scenario - 5% AEP
